# *Safe Guard Property Inspections, LLC*

## Residential Inspection Report

232 John Muir Rd., Lake Arrowhead , CA 92352  
Inspection prepared for:  
Real Estate Agent: Monique Richter - Dilbeck Real Estate

Date of Inspection: 4/30/2019 Time: 11:00  
Age of Home: 1930 Size: 2625  
Weather: Sunny  
Agent buyers present, Buyers present, Inspector present

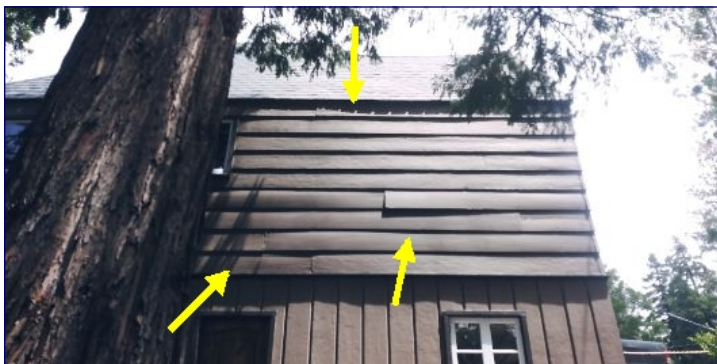
Loose siding present at multiple locations and we recommend service.

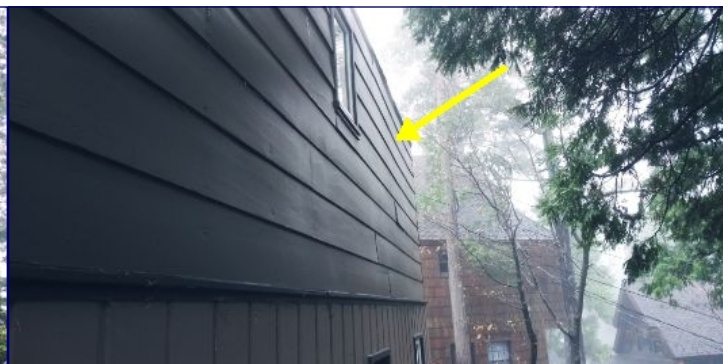
Loose siding present at multiple locations and we recommend service.

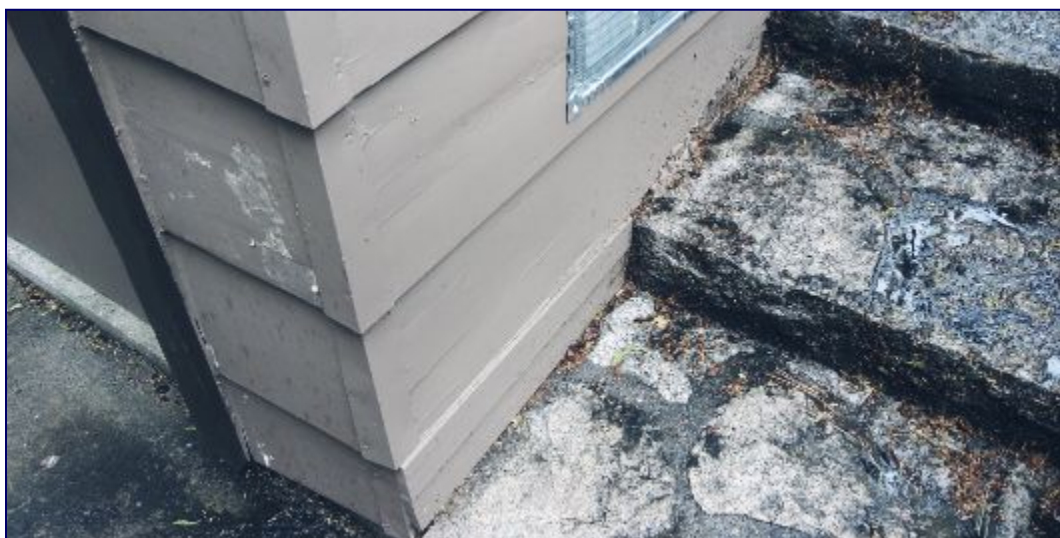
Wood siding is ran into the concrete and/or dirt, which will promote rot and termite infestation. Local standards require a 4" separation when dirt is present and 2" when concrete is present. We recommend further evaluation and service.

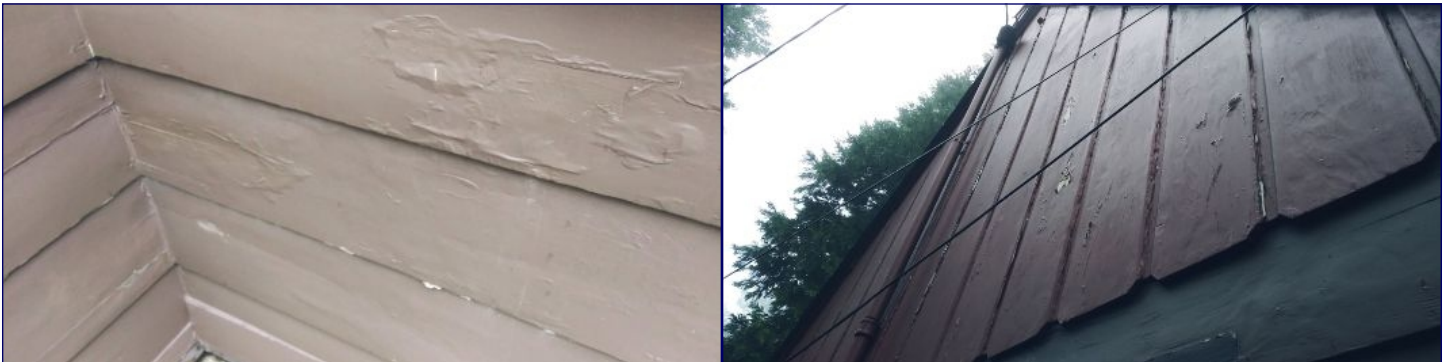
Peeling paint present and we recommend service. Homes constructed pre 1978 to 1982, lead based paint is likely to be present and testing should be done to determine for certain. If the presence of lead is confirmed the painting, paint prep, and/or paint removal should be completed by a licensed painting contractor who holds a certification in handling and servicing lead based paint.

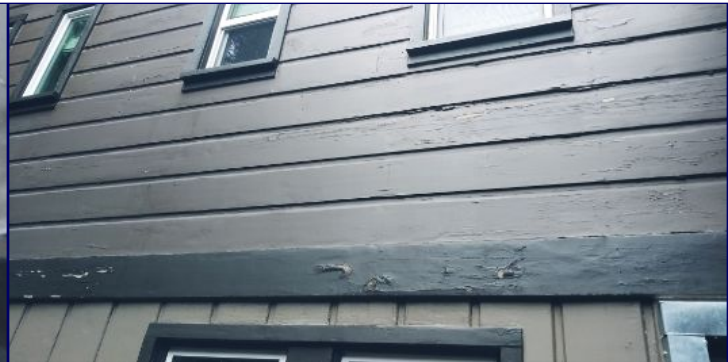
Peeling paint present and we recommend service. Homes constructed pre 1978 to 1982, lead based paint is likely to be present and testing should be done to determine for certain. If the presence of lead is confirmed the painting, paint prep, and/or paint removal should be completed by a licensed painting contractor who holds a certification in handling and servicing lead based paint.

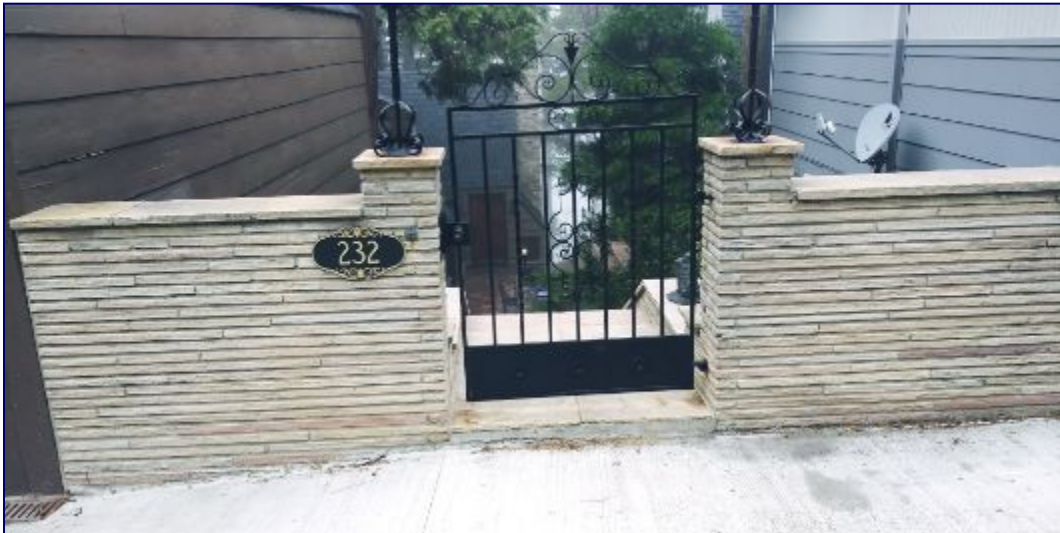
Entry gate of entry level appears to be installed out of square. In addition, we were unable to test the system due to the presence of a keyed lock and no key. We recommend further evaluation and service.

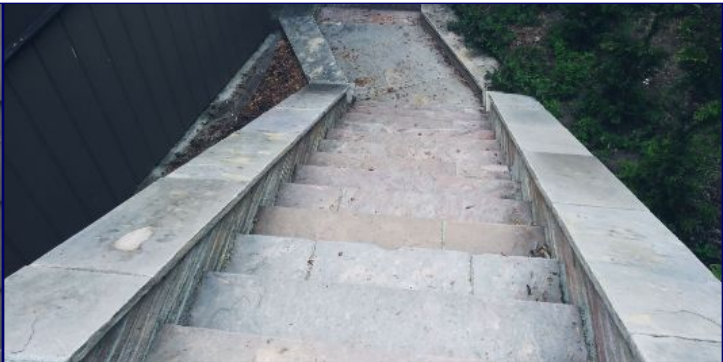
There should be a graspable handrail installed where there is three or more risers and we recommend service.

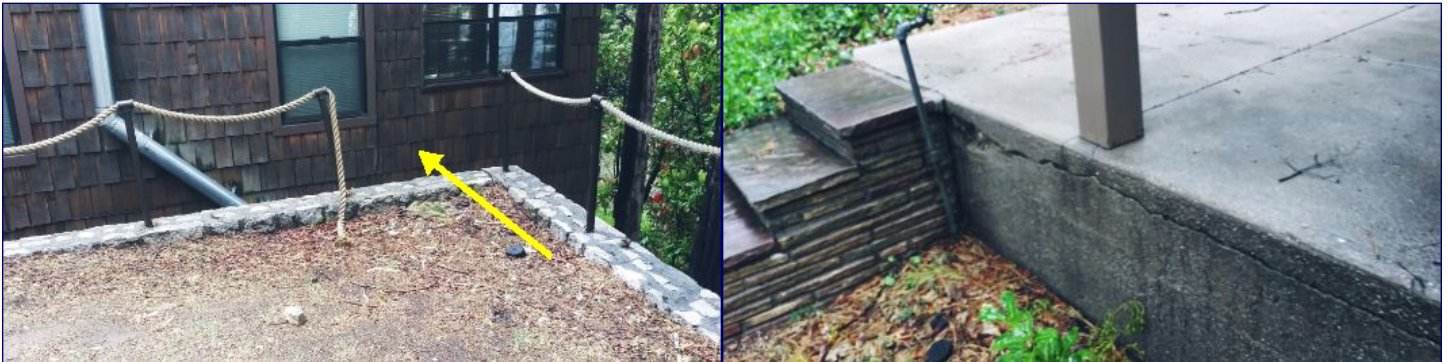
Sections of rope style railing are damaged and/or missing at one or more locations. We recommend further evaluation and service.

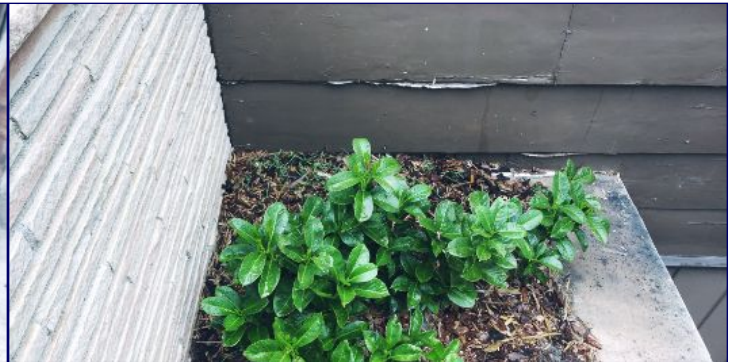
Planters will trap water against foundation and we recommend adjusting grade to slope away or adding adding drains

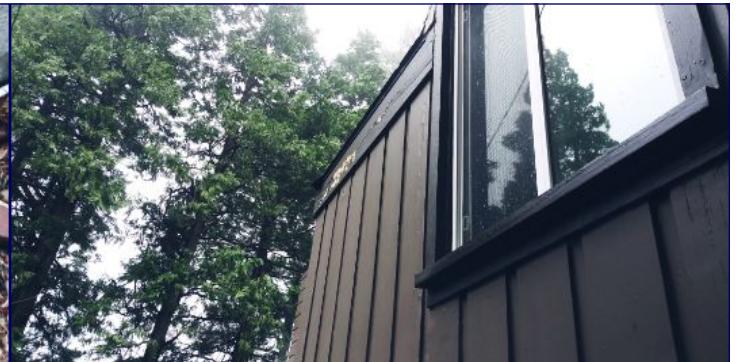
Trees and/or tree branches are threatening the roofing materials and/or surfaces. We recommend the aforementioned condition be further evaluated by a licensed arborist prior to the close of escrow. Local standards require trees branches to be cut back a minimum of 10' from the roof line and/or surface. We recommend further evaluation and service.

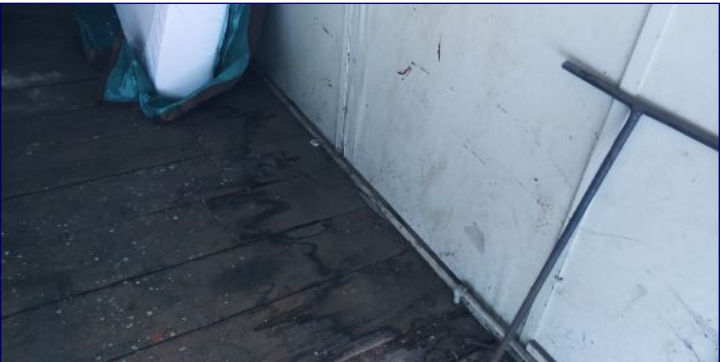
Water damaged, wood rot, and other moisture related damages appear to be present at the base of the wall off the entrance to the garage. We highly recommend further evaluation and service by a licensed termite inspector.

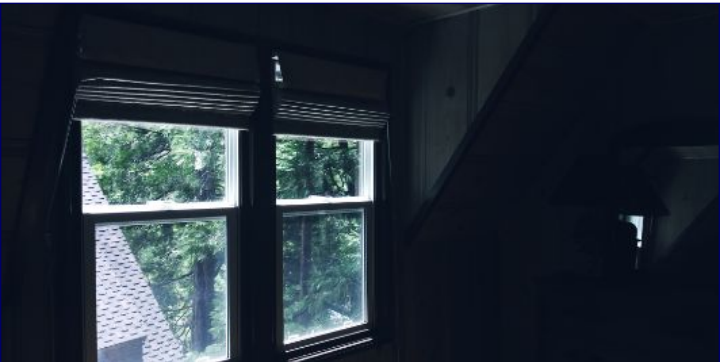
Current standards call for at least two means of emergency egress at every bedroom location. No visible qualifying method of secondary egress was found to be present at all bedroom locations. To qualify the egress systems must comply with minimum emergency egress standards. When two or more doors are not present, which provide egress, at least one window or comparable system must be present which employs a clear opening of a minimum 5.7 square feet, a minimum opening with a width of 20.5", a minimum open vertical opening of 24" , and have a sill height of no more than 44" in vertical height from floor surface. We recommend upgrading the windows located within the bedroom locations to comply with minimum safety standards relevant to the period of time the windows were replaced.

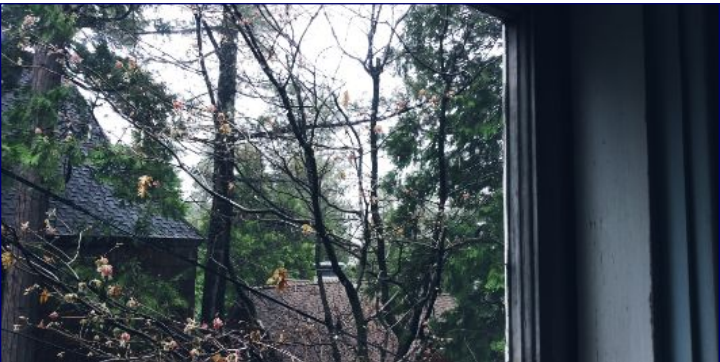
Broken glass at two locations off the detached garage are present, which is a safety hazard and a security issue and we recommend replacement prior to occupancy.

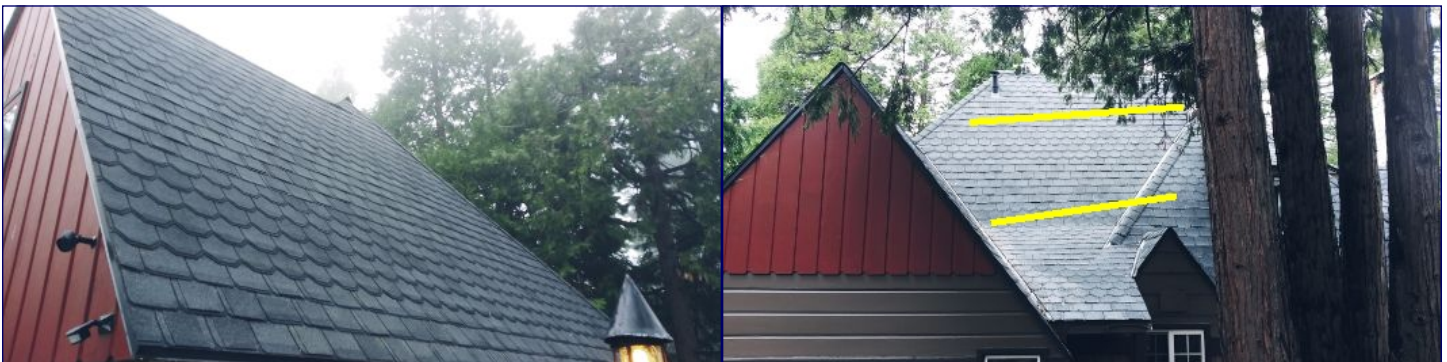
From the rear of the detached structure, when observing the front elevation of the main structure, it appears one or more courses of roof shingles have been laid out of square with the roof structure. The aforementioned condition could indicate that the installation of the roof was done in a sub standard manner. Therefore, we recommend verification of installation permits and further evaluation by a licensed roofing contractor prior to the close of escrow.

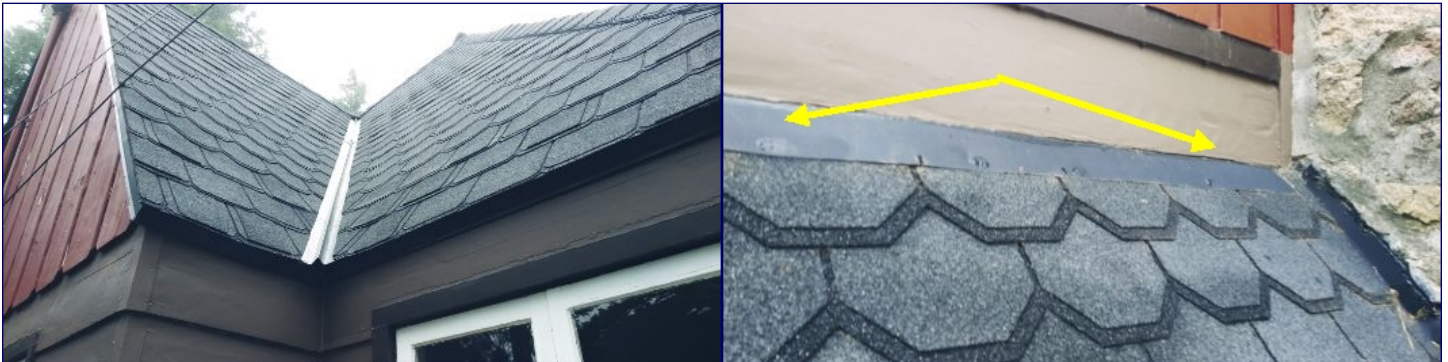
Nails have been improperly placed through the face of the flashing, exposed to the weather. These penetrations will need to be maintained.

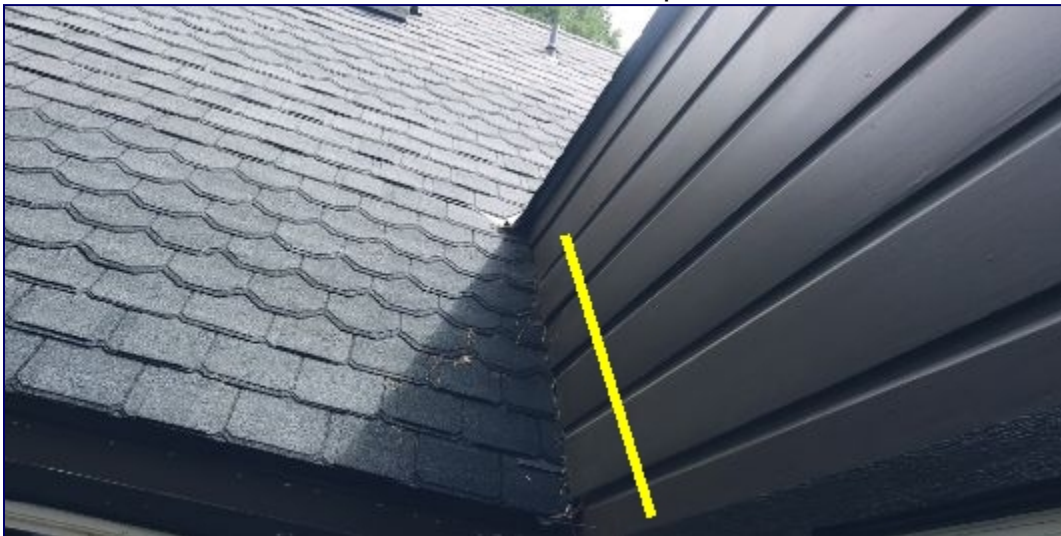
It appears at one or more roof to wall transitions that there are no functional roof to wall flashing present, which is contrary to industry standards and will likely promote deterioration and moisture intrusion. We recommend further evaluation and service.

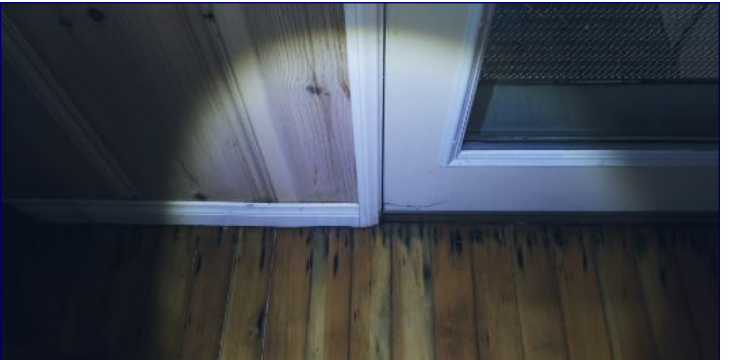
Visible moisture damages are present at the base of the wall and ceilings within the sublevel den. We recommend further evaluation and service by a licensed moisture intrusion specialist.

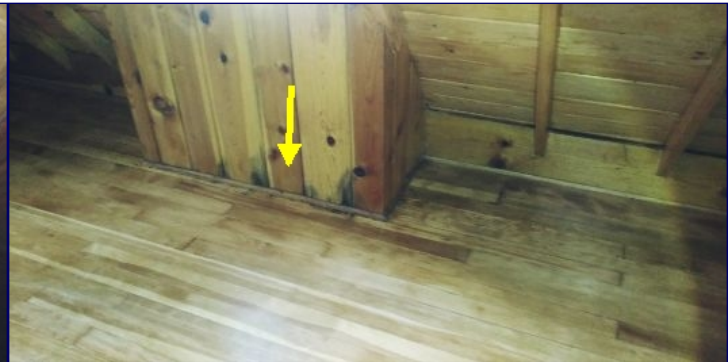
Moisture related damages are present at the base of the wall within the interior of the main structure, off the top floor bedroom areas. We recommend further evaluation and service by a licensed moisture intrusion specialist.

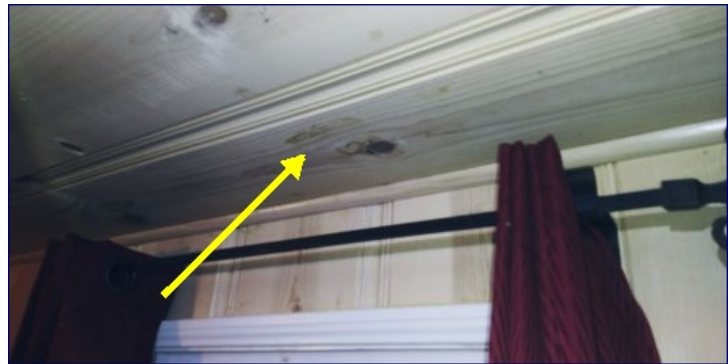
Visible moisture damages are present at the base of the wall and ceilings within the sublevel den. We recommend further evaluation and service by a licensed moisture intrusion specialist.

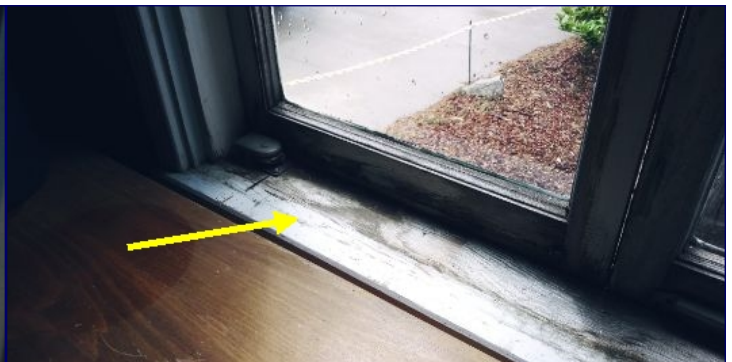
Visible moisture related damages present beneath the window sill within bedroom three. We recommend further evaluation and service.

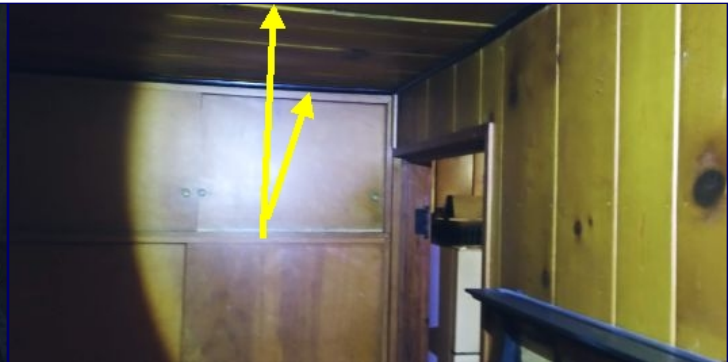
There are abnormal and significantly uneven areas in the flooring, ceilings, and interior door openings were found to be present at one or more locations within the foyer, dining room, and main hall locations. We highly recommend further evaluation and service by a licensed structural engineer prior to the close of escrow.

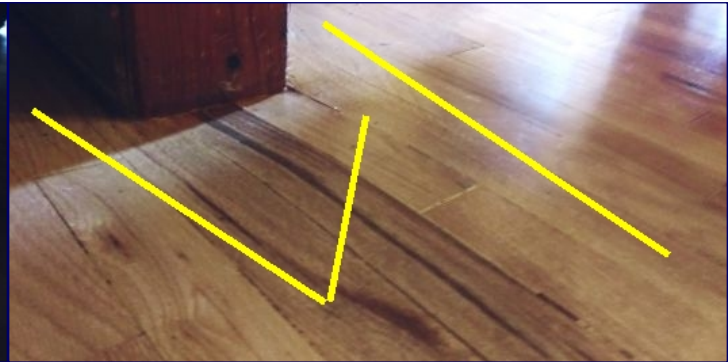
There are abnormal and significantly uneven areas in the flooring, ceilings, and interior door openings were found to be present at one or more locations within the foyer, dining room, and main hall locations. We highly recommend further evaluation and service by a licensed structural engineer prior to the close of escrow.

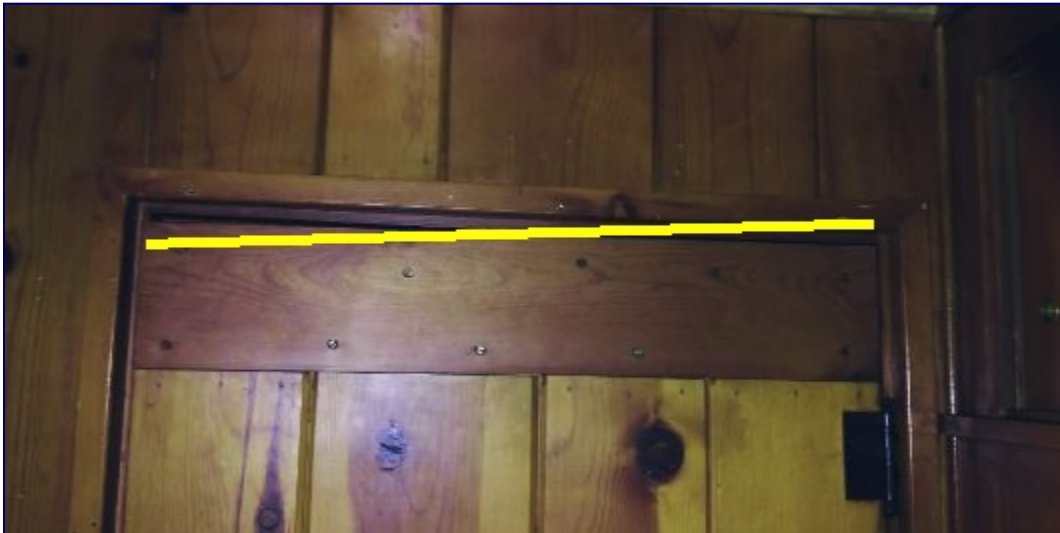
Multiple uneven door reveals present, indicating out of square openings.

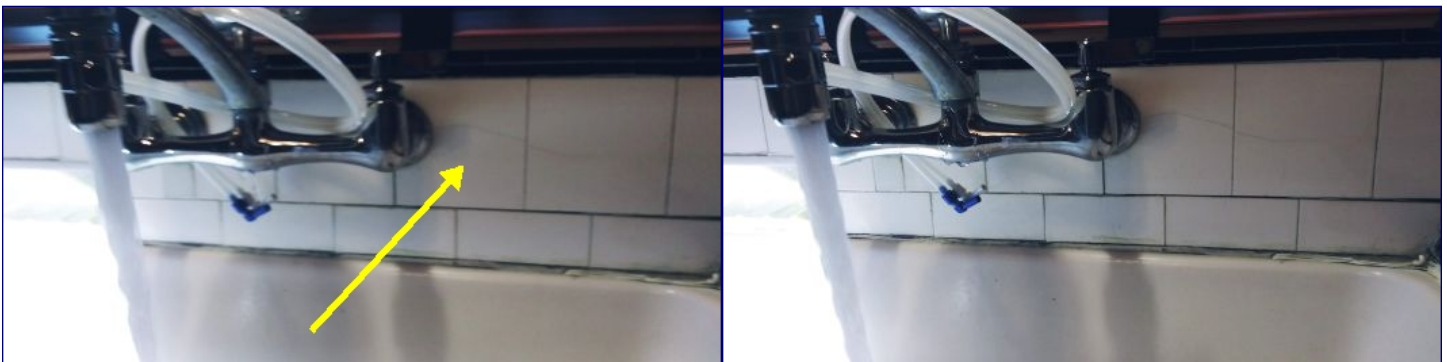
We have noted one or more cracked tiles at multiple locations within the kitchen and bathroom facilities.

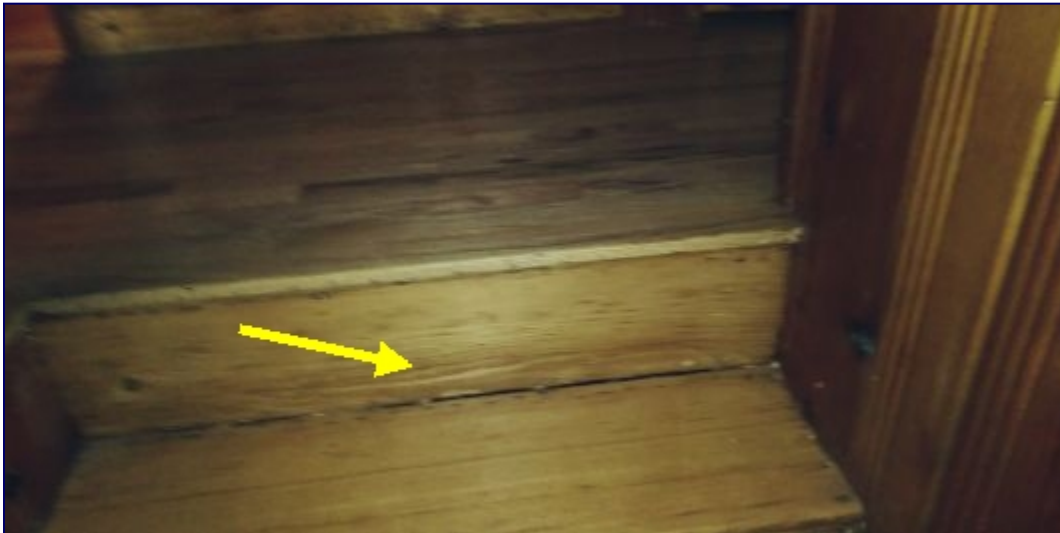
Loose treads at one or more locations are present at the interior stair systems. We recommend further evaluation and service.

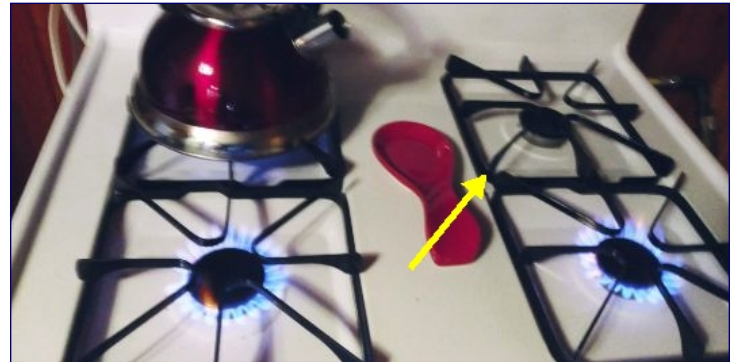
Igniter did not function and should be repaired at the top right burner. We recommend further evaluation and service.

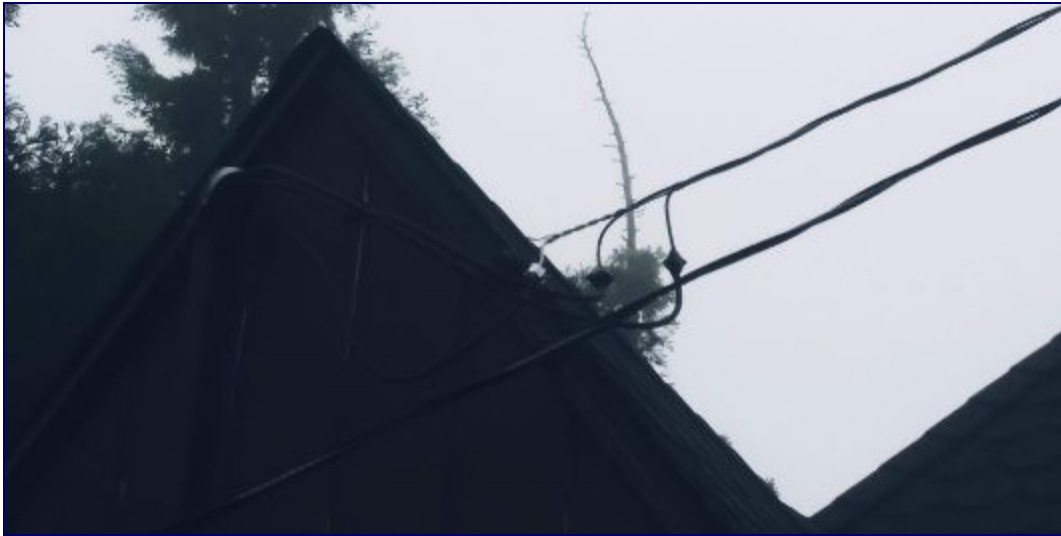
overhead-The service entrance mast weather head and cleat are in acceptable condition

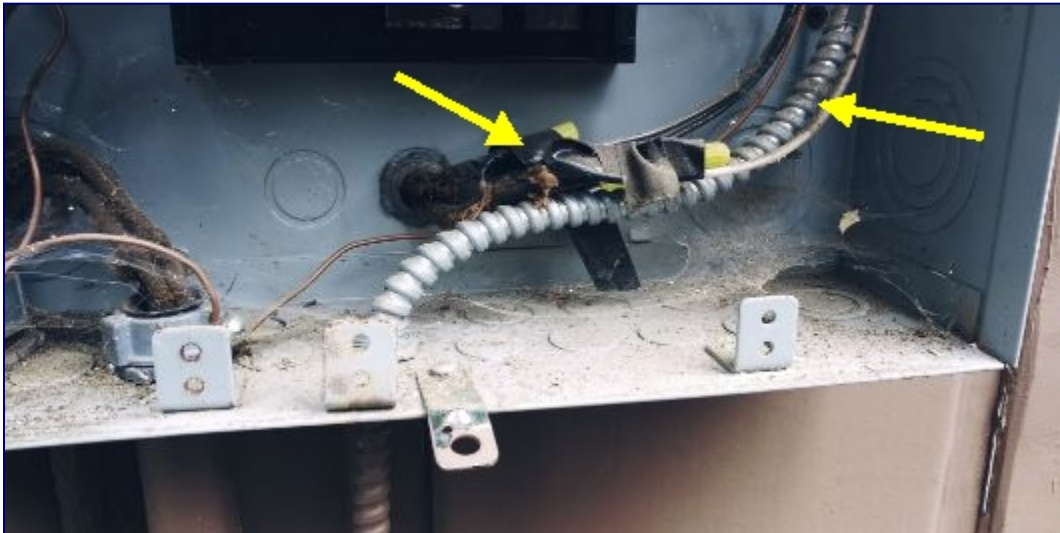
There are spliced connections inside of the panel, which indicates substandard workmanship, possible additions to the system, and/or circuits were ran too short when installed originally. Regardless we recommend further evaluation and service by a licensed electrician.

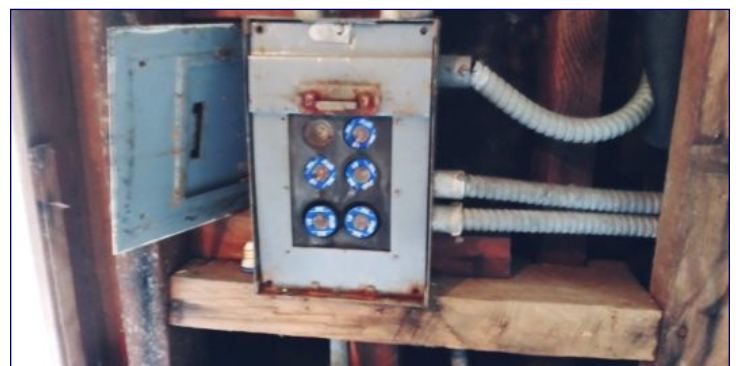
The subpanel employs a fuse operated system which is obsolete and we recommend replacement of the system to reflect common safety standards.

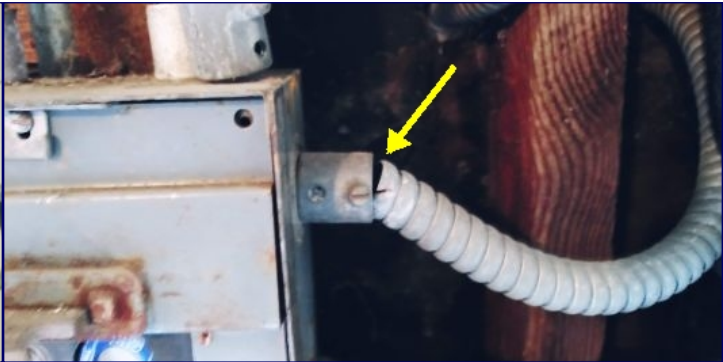
Damaged electrical conduit adjacent to the sub panel located within the laundry room of the detached structure. We recommend further evaluation and service.

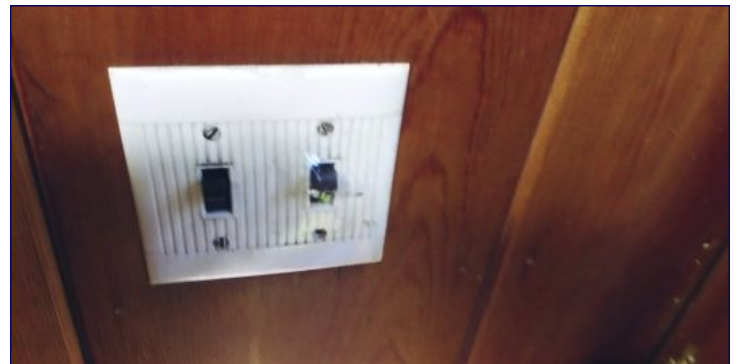
In one or more locations (sublevel main house) we have noted exposed electrical cables ran on the surface of interior walls, which is not permitted. The aforementioned condition is a potential shock hazard and therefore we recommend further evaluation and service by a licensed electrician prior to the close of escrow.

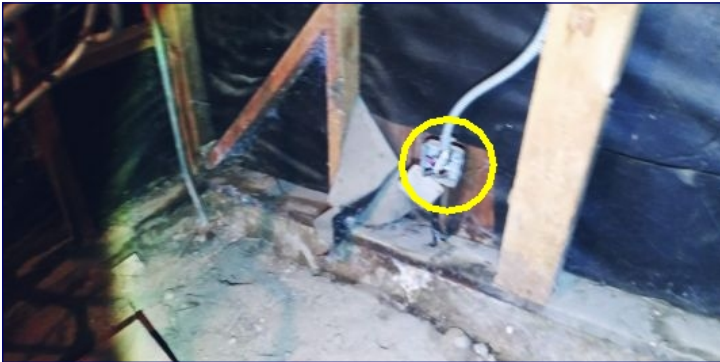
There are multiple unsafely installed electrical connections and/or electrical junctions within the attic. Exposed, spliced, and/or wire natted electrical connections are present outside of a junction box or within a unsealed junction box, either method of installation will not contain electrical arching. This method of installation is easily repaired, but at the same time, is a serious fire and shock hazard. All electrical connections should be made within an approved UL listed junction box, which is properly sealed to contain random arching and we recommend service prior to further occupancy.

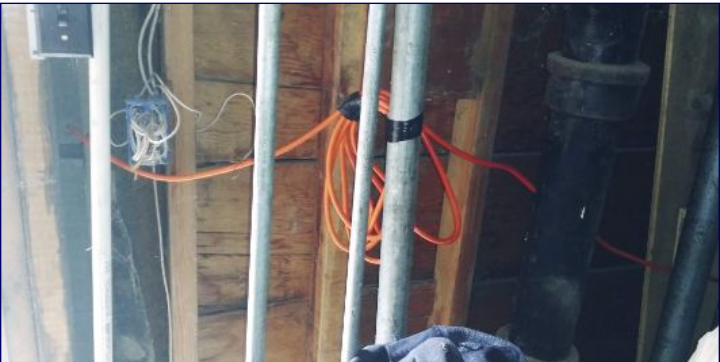
There are extension cords employed within the attic to supply power to a fixture, or multiple fixtures, which is not permitted and is a safety hazard. We recommend further evaluation and service by a licensed electrician.

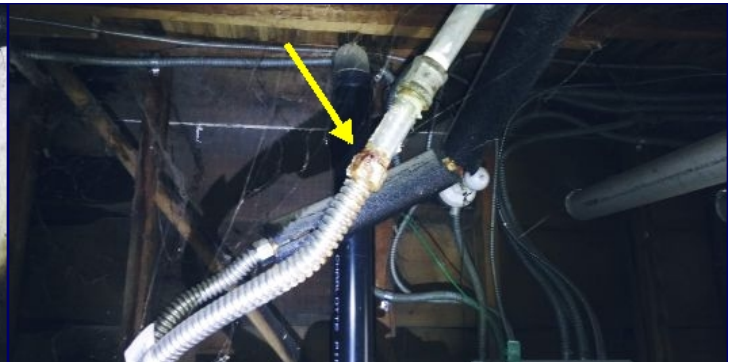
There are blisters on the body of the galvanized water pipes that should be evaluated

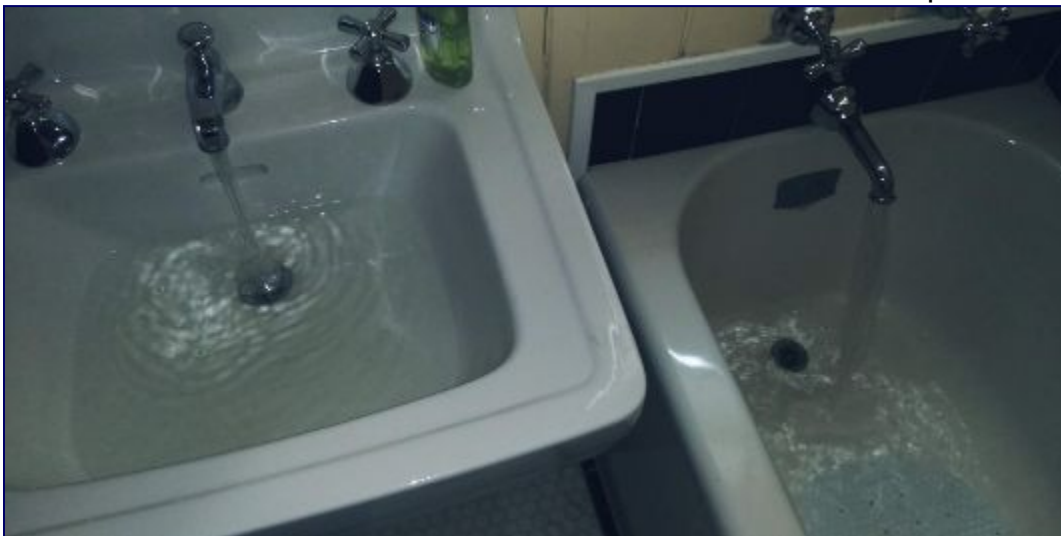
There is a moderate reduction in water volume and a clamp repair in the foundation area

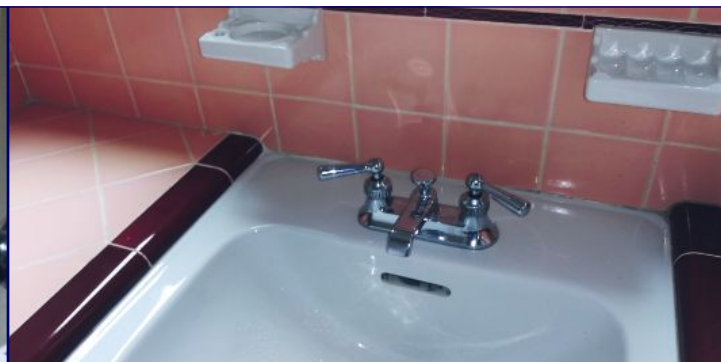
One or more faucets leak when in use. We recommend further evaluation and service by a licensed plumbing contractor.

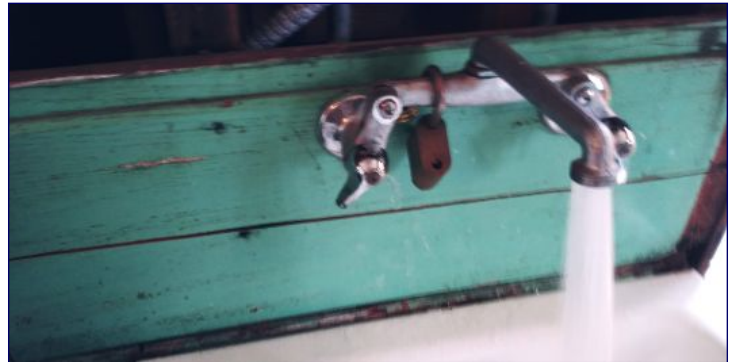
Visible leaking at the water mixing valve located at the laundry sink, within the detached structure. We recommend further evaluation and service by a licensed plumbing contractor.

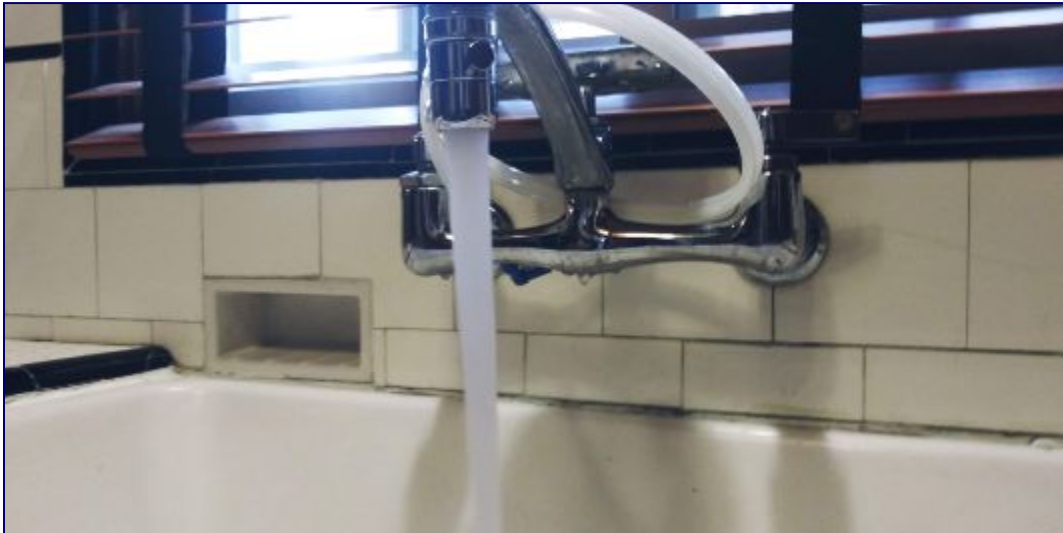
Faucet leaks at kitchen sink. We recommend further evaluation and service.

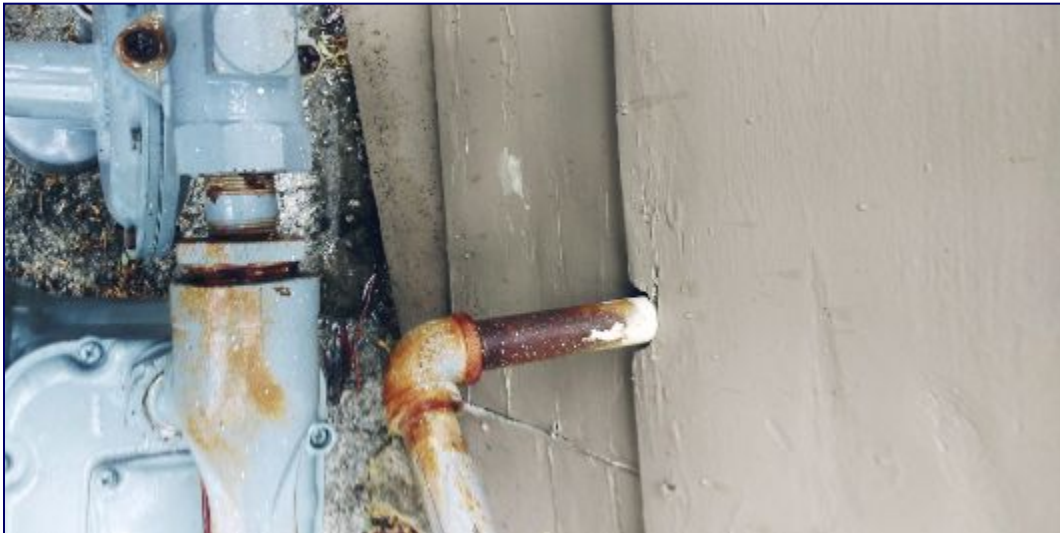
The gas main and meter are loose and should be secured.

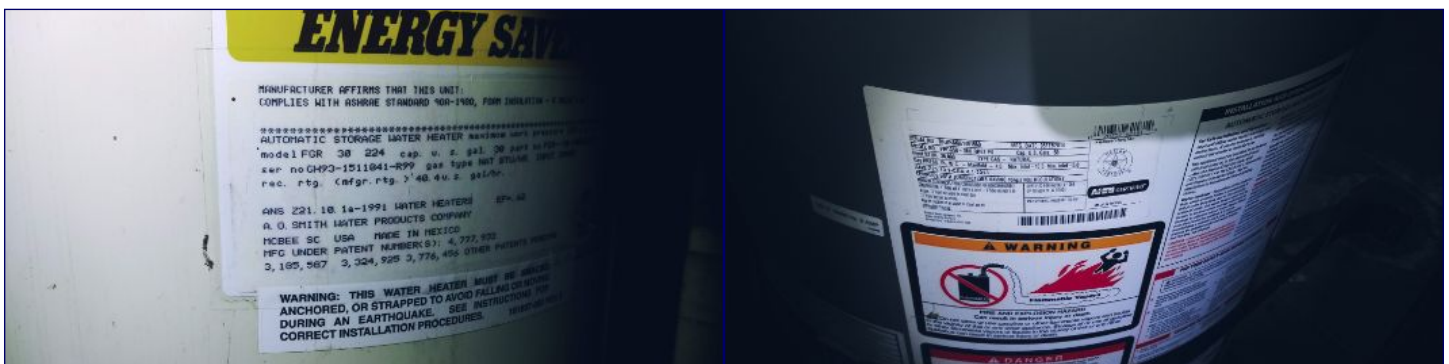
older unit (+20 years) located within the detached structures laundry facilities. We recommend further evaluation and service.

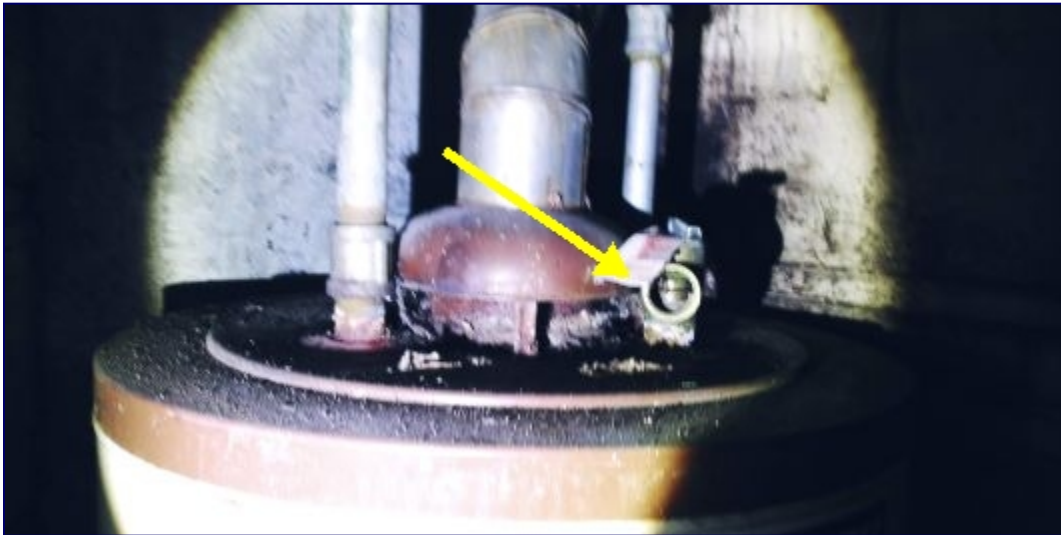
The pressure relief line dose not extend to exterior at the laundry room unit and will cause damages to building materials and/or injury, when hot water is discharged due to excessive pressure. We recommend running the 3/4" discharge line to an approved location, as required by local building standards.

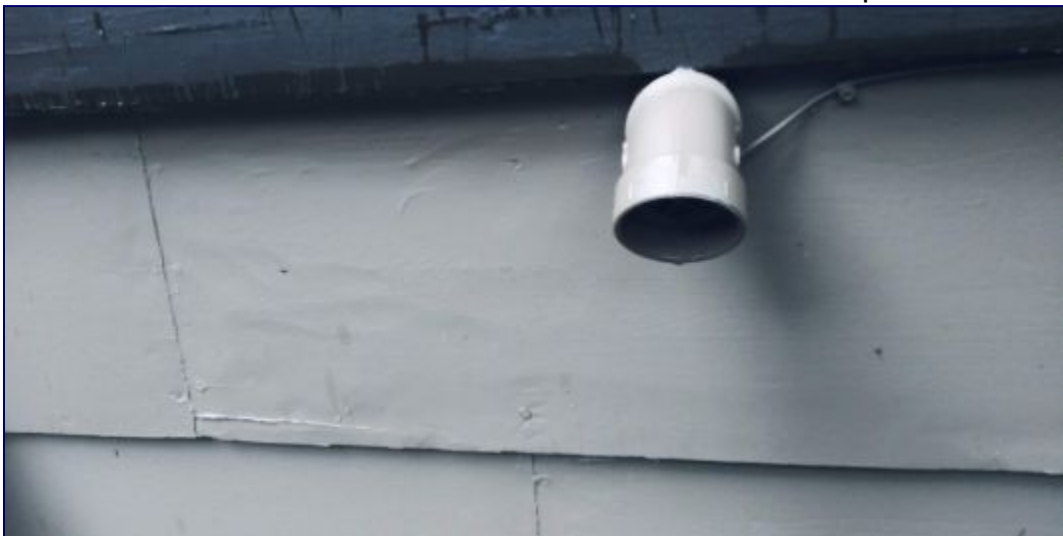
The termination method is improper and missing a screened port to prevent access to rodents at the water heater vent located beneath the main house off the left elevation. We recommend further evaluation and service.

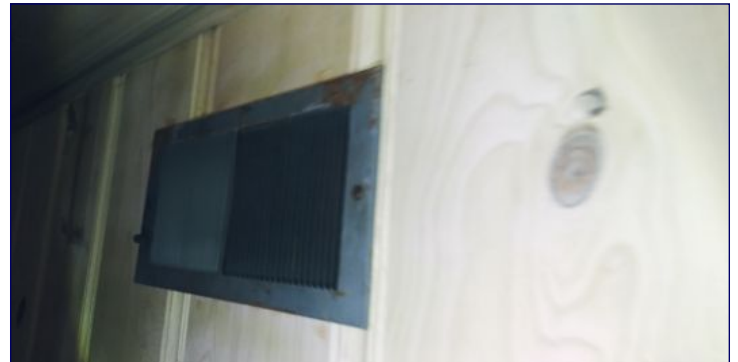
One or more supply and/or return registers are deteriorated due to moisture exposure. Rust is present within the metal ducting system due to the system be ran through the corrosive concrete foundation . We recommend further evaluation by a licensed HVAC contractor with the intention of the replacement of the system.

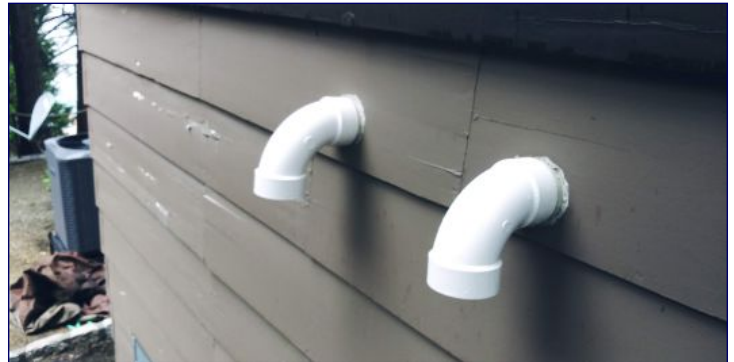
The termination method at the intake and exhaust ports for the FAU are not installed per the manufacturers installation instructions. We recommend further evaluation and service by a licensed HVAC contractor.

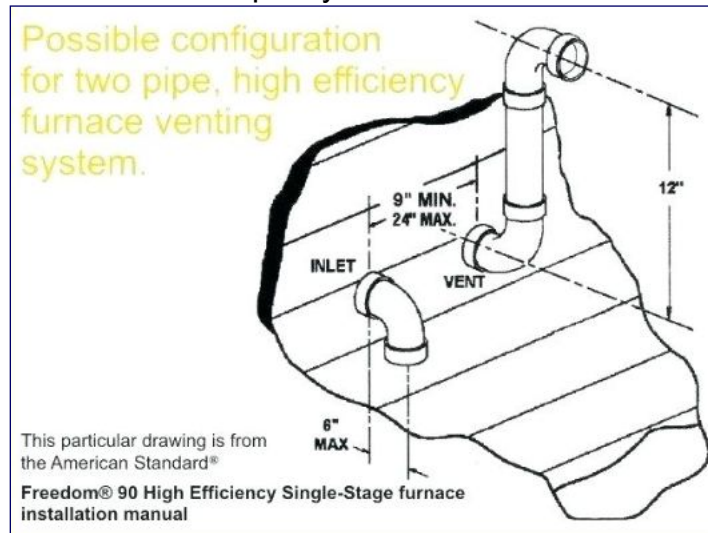
The termination method at the intake and exhaust ports for the FAU are not installed per the manufacturers installation instructions. We recommend further evaluation and service by a licensed HVAC contractor.

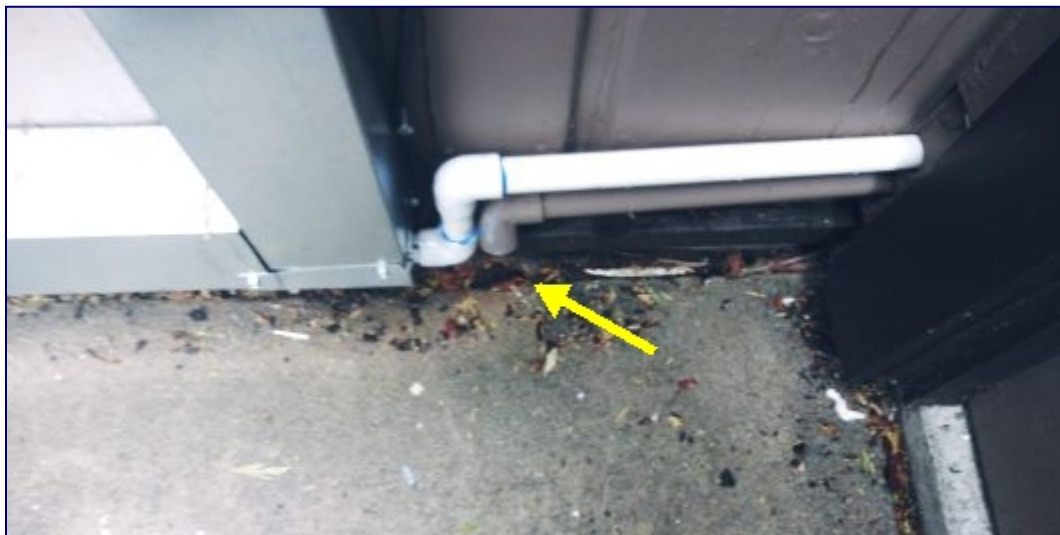
The primary drains to the base of the foundation, which will deteriorate foundation components and increase moisture levels. We recommend installing a drain under the condensation line to prevent moisture from pooling at the perimeter of the foundation.

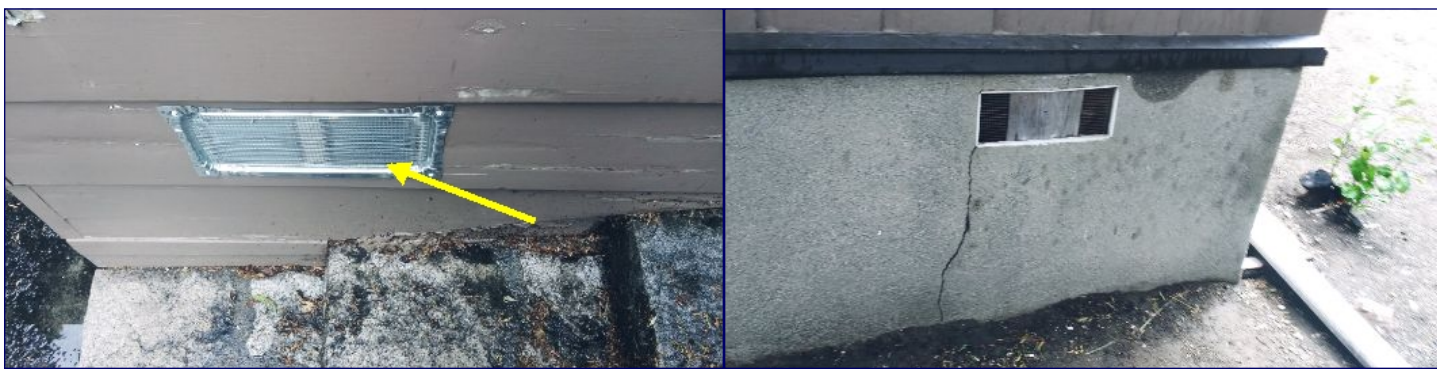
One or more vent flashing systems have been installed in reverse of the manufacturers design. We recommend further evaluation and service at the left elevation.

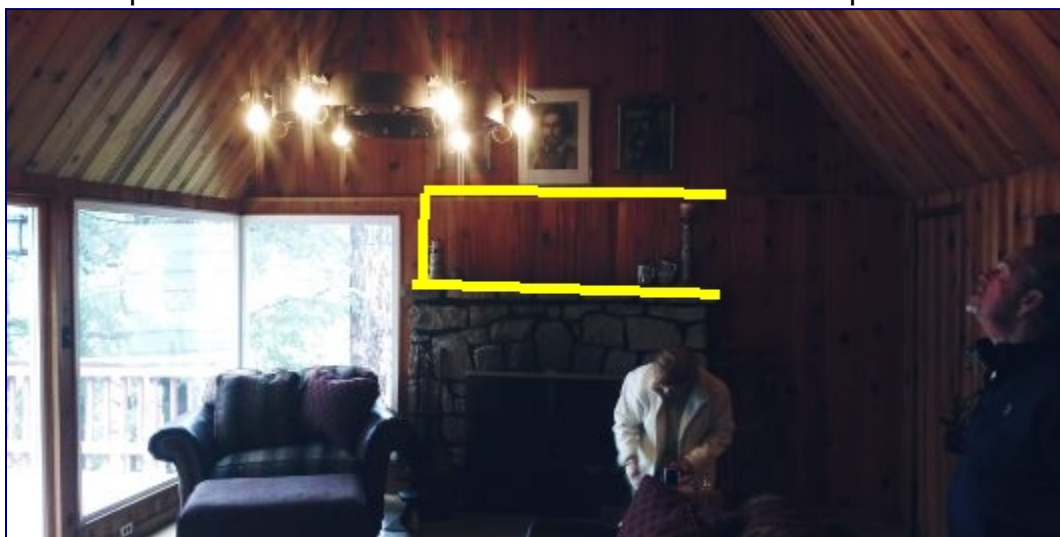
Based on measurements taken at the interior mantel, the living room fireplace appears to have shifted, and now sits out of square. In addition, it appears that a large portion of the upper masonry stack has been rebuilt, based on materials differences and grout color inconsistencies. Based on the two aforementioned observations, it is our recommendation the fireplace be further evaluated by a Licensed NFPA inspector prior to any attempts to utilize.

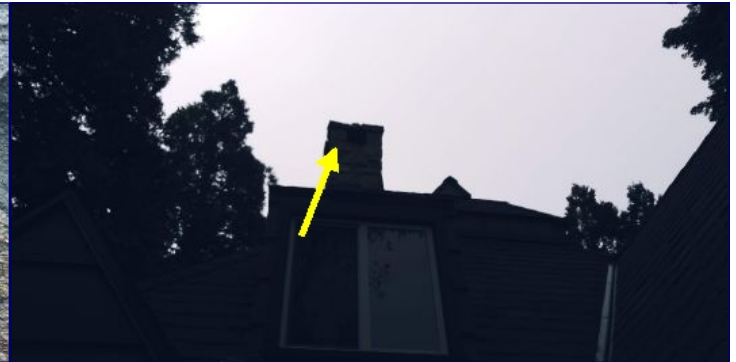
Cracked and deteriorated crown, which should be serviced to prevent additional damages.

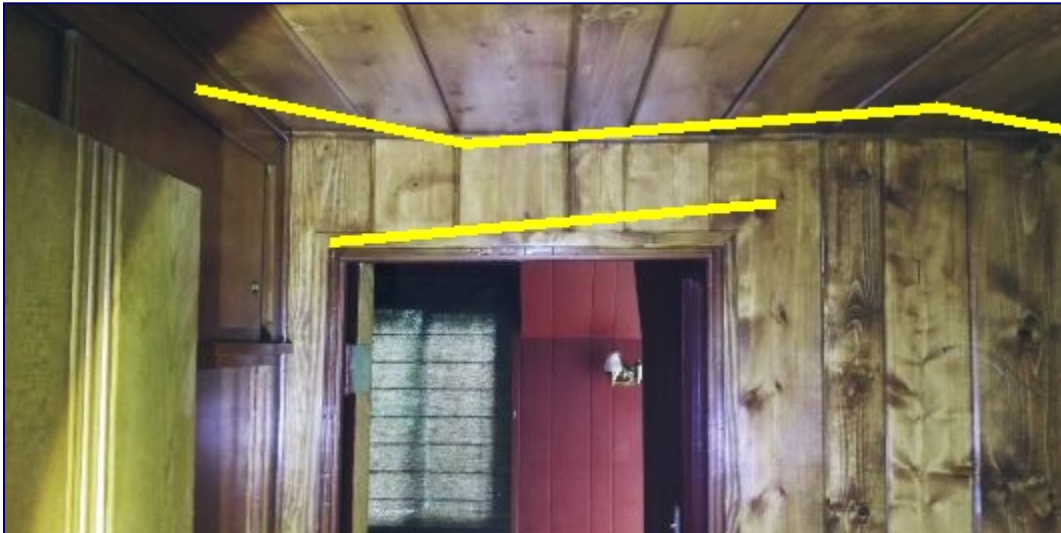
Interior door reveals are unequal at one or more location, uneven flooring materials, out of level ceilings have all been observed. These observations may indicate a more serious structural defect is present or is occurring in areas not visible to our inspector due to finish surfaces. We recommend the structure be further evaluated by a structural engineer.
