# *Safe Guard Property Inspections, LLC*

## Residential Inspection Report

232 John Muir Rd., Lake Arrowhead , CA 92352  
Inspection prepared for:  
Real Estate Agent: Monique Richter - Dilbeck Real Estate

Date of Inspection: 4/30/2019 Time: 11:00  
Age of Home: 1930 Size: 2625  
Weather: Sunny  
Agent buyers present, Buyers present, Inspector present

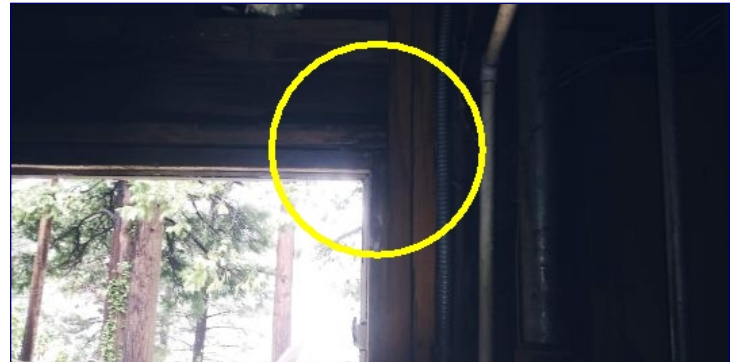
Foundation access door not framed correctly to properly transfer structural load over and around the opening as required and often opiortrayed with a typical header to king stud connection. We recommend further evaluation and service by a licensed structural engineer.

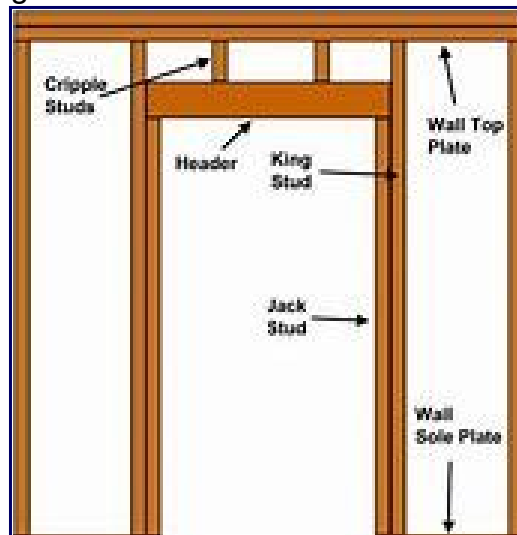
Foundation access door not framed correctly to properly transfer structural load over and around the opening as required and often opiortrayed with a typical header to king stud connection. We recommend further evaluation and service by a licensed structural engineer.

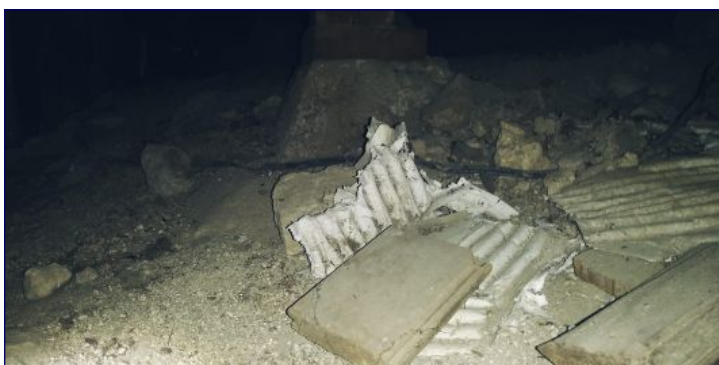
There is trash located within the crawlspace, which will promote fungus growth and the introduction to pests.

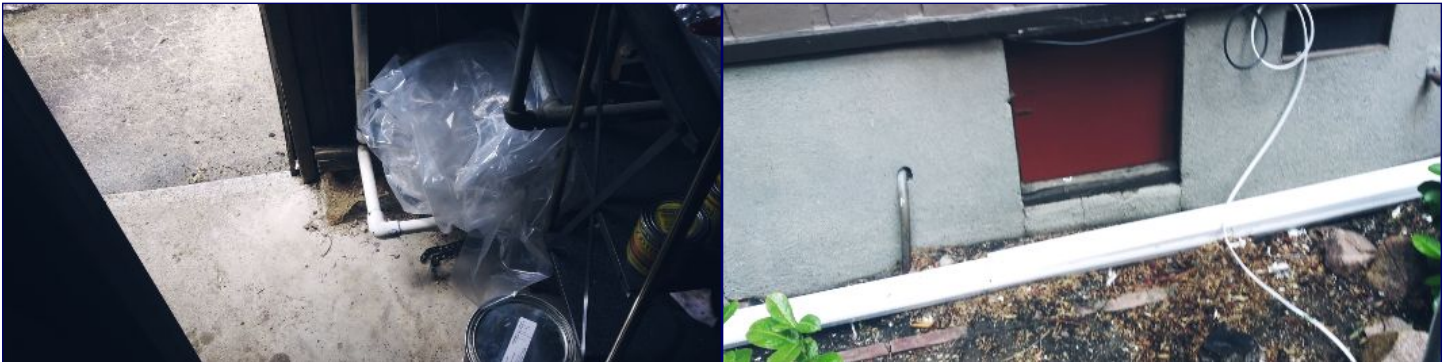
There is evidence of water in the crawlspace and a chronic moisture problem that should be evaluated with the intention of servicing the irrigation, drainage and grading systems. Dampness beneath the home will promote the deterioration of structural connectors, growth of mold, vegetation growth, and possible infestation of unwanted insects and bugs.

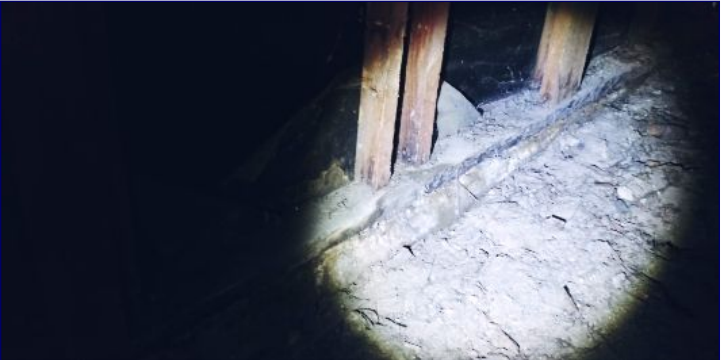
Sections of the concrete foundation walls we observed as being deteriorated, missing, removed, and/or severely out of plumb at one or more locations within the crawlspace of the main structure, as well as within the detached unit. The foundation wall has been skimmed coated in areas, which is falling off the structure and in need of repair. The rear foundation wall was observed and measured as being over an 1.5" out of plumb, leaning towards the tow of the slope. Furthermore we observed sections of concrete foundation walls missing, damaged, and/or spalling and therefore we highly recommend a complete evaluation by a licensed structural engineer and/or a licensed concrete repair specialist prior to the close of escrow.

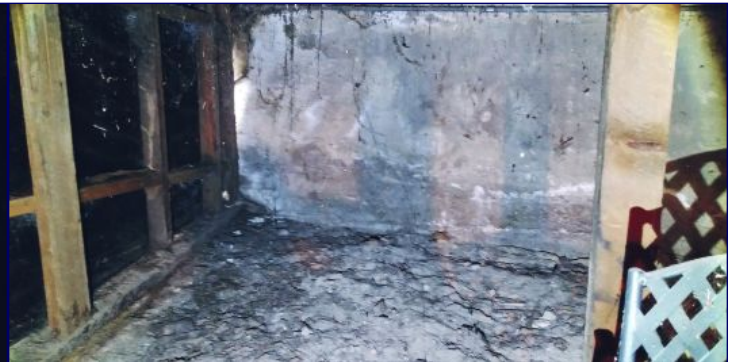
There is efflorescence on the stem walls of the raised foundation and damp soils. This condition confirms moisture penetration and we recommend service to the grading and drainage systems. Efflorescence deteriorates the strength of the concrete walls and should be addressed to minimize deterioration and prolong the service life of the foundation system

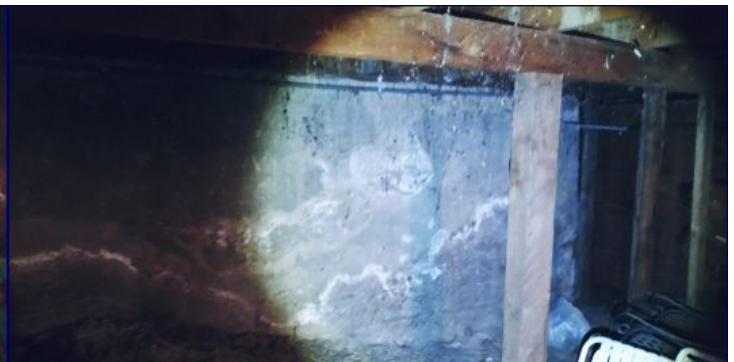
There is efflorescence on the stem walls of the raised foundation and damp soils. This condition confirms moisture penetration and we recommend service to the grading and drainage systems. Efflorescence deteriorates the strength of the concrete walls and should be addressed to minimize deterioration and prolong the service life of the foundation system

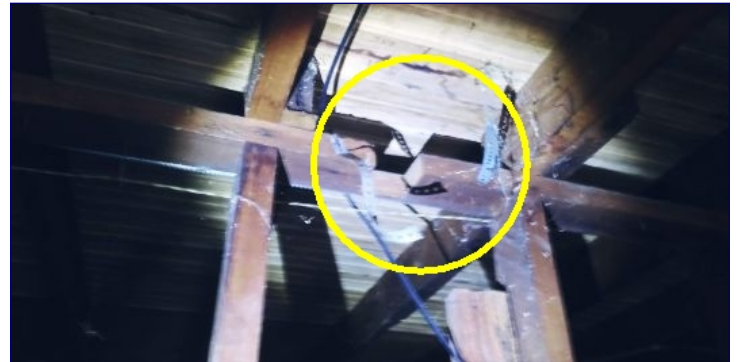
Over cuts in plate lines located at the top of one or more cripple type wall sections were observed within the foundation crawlspace. In addition, sections of cripple type bearing systems appeared to bow and lean at one or more locations beneath the main structure, visible from within the crawlspace area. We highly recommend further evaluation and service by a licensed structural engineer prior to the close of escrow.
