# *Safe Guard Property Inspections, LLC*

## Residential Inspection Report

232 John Muir Rd., Lake Arrowhead , CA 92352  
Inspection prepared for:  
Real Estate Agent: Monique Richter - Dilbeck Real Estate

Date of Inspection: 4/30/2019 Time: 11:00  
Age of Home: 1930 Size: 2625  
Weather: Sunny  
Agent buyers present, Buyers present, Inspector present

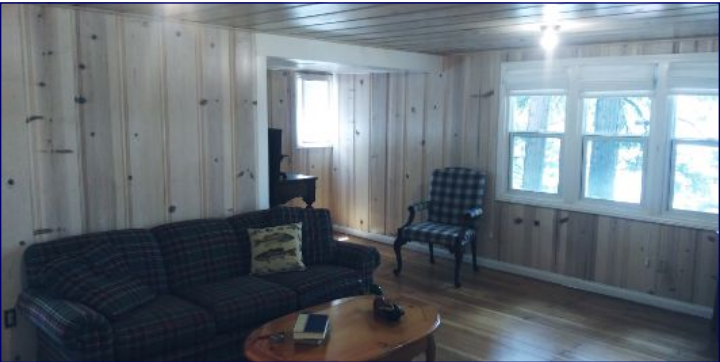
Sub level den

| Page 41 Item: 1 | Interior Surfaces and Flooring Observations | <ul style="list-style-type: none"> <li>• Visible moisture damages are present at the base of the wall and ceilings within the sublevel den. We recommend further evaluation and service by a licensed moisture intrusion specialist.</li> <li>• The vinyl flooring possibly contains asbestos materials and is loosely or wavy in its appearance where located within the loft bedroom within the detached structure. We recommend further evaluation and abatement by a licensed asbestos abatement contractor.</li> <li>• Moisture related damages are present at the interior window sill within one or more locations at the interior of the detached living space, indicating moisture intrusion. We recommend further evaluation and service by a licensed moisture intrusion specialist.</li> <li>• There are abnormal and significantly uneven areas in the flooring, ceilings, and interior door openings were found to be present at one or more locations within the foyer, dining room, and main hall locations. We highly recommend further evaluation and service by a licensed structural engineer prior to the close of escrow.</li> <li>• We have found water damage and visible fungus growth throughout the interior cabinetry located within the laundry room. We recommend removal of the damaged wall material as well as any components damaged that are located beneath the drywall. The area should be properly remediated and treated with a fungicide to help minimize the allergic affects fungus growth can have on individuals. In addition, after repairs have been made we recommend the area be tested by our mold inspector to determine proper remediation has been completed and safe spore count levels, moisture content and humidity levels have been restored.</li> <li>• Moisture related damages are present at the base of the wall within the interior of the main structure, off the top floor bedroom areas. We recommend further evaluation and service by a licensed moisture intrusion specialist.</li> <li>• Visible moisture related damages present beneath the window sill within bedroom three. We recommend further evaluation and service.</li> </ul> |

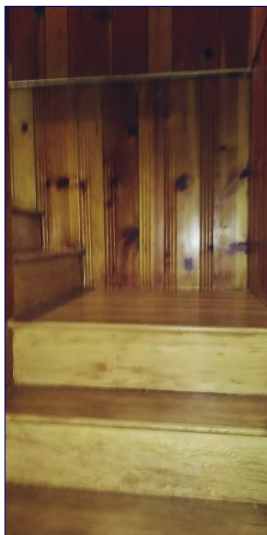
At one or more locations we found that no graspable handrail system was present at the time of our inspection, as would be required under todays building and safety standards. We recommend further evaluation and service.

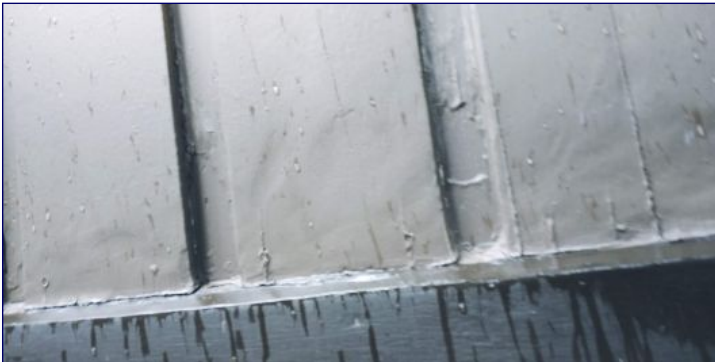
Sections of the fascia board or wood trim are weathered

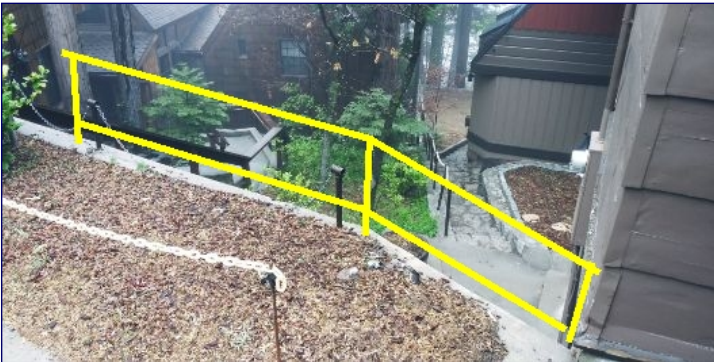
We recommend installing a handrail system where a drop in elevation of 30" or more is present at known paths of travel, as local building standards would require. We recommend further evaluation and service.

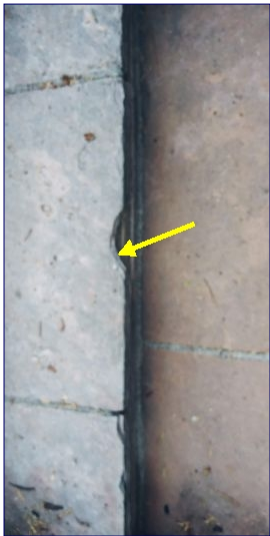
Damaged steps at masonry stair system at one or more locations. We recommend service.

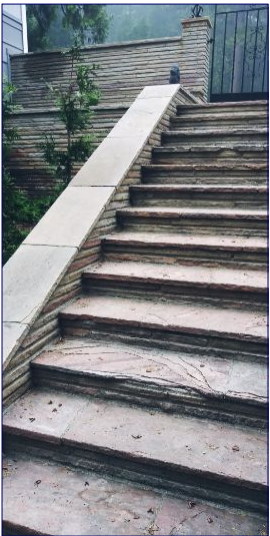
There should be a graspable handrail installed where there is three or more risers and we recommend service.

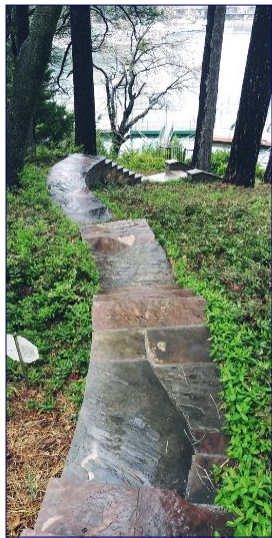
There should be a graspable handrail installed where there is three or more risers and we recommend service.

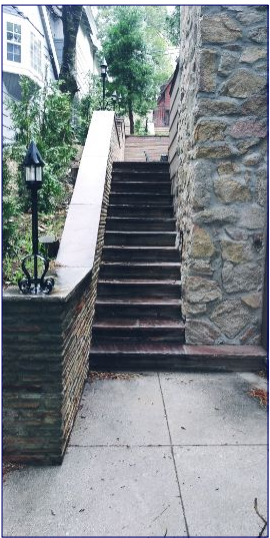
There should be a graspable handrail installed where there is three or more risers and we recommend service.

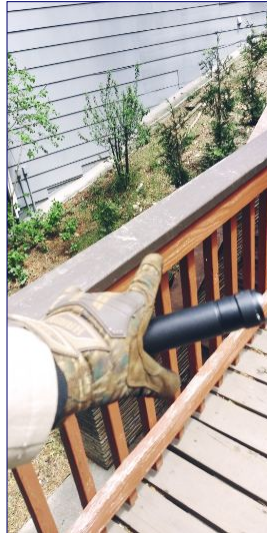
One or more handrail locations have a height below 36", which is not permitted and we recommend replacement.

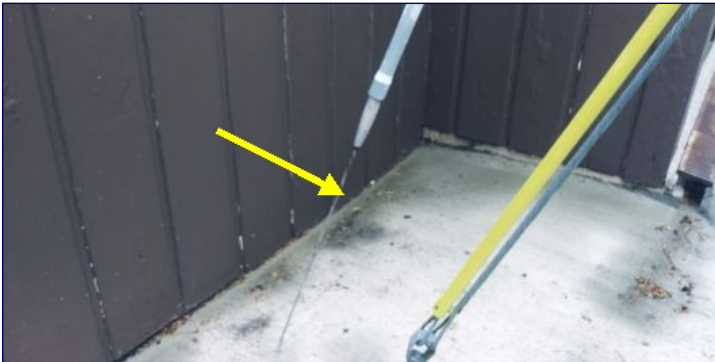
There are areas around the home where grading is negative or neutral to the residence. The properties grade should slope so that water is lead away from the homes foundation. This can be easily rectified by adding additional drainage.

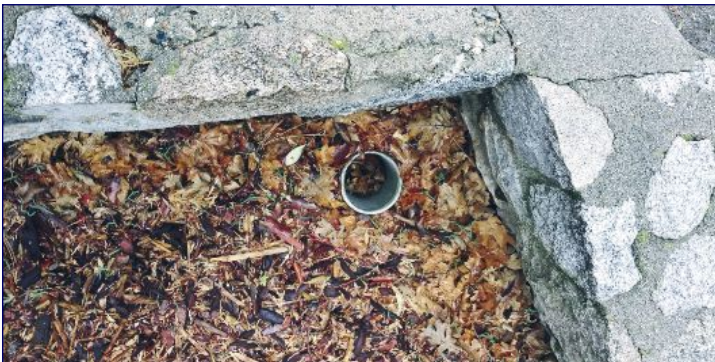
Asbestos pipe located in yard, unknown use. We recommend an inquiry be made with the selling party prior to the close of escrow.

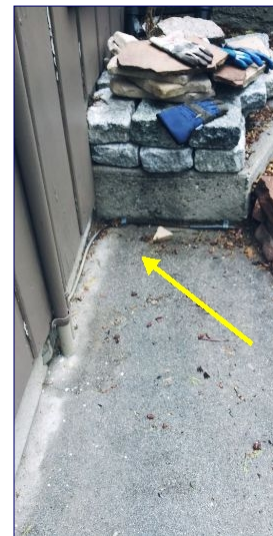
The current drainage system is inadequate for the amount of potential water the lot can produce. The grading, drainage, and/or irrigation system should be evaluated by a licensed contractor specializing in drainage, grading, soil loss prevention, and soil retainment prior to the close of escrow to determine the scope of potential costs and scope of work required.

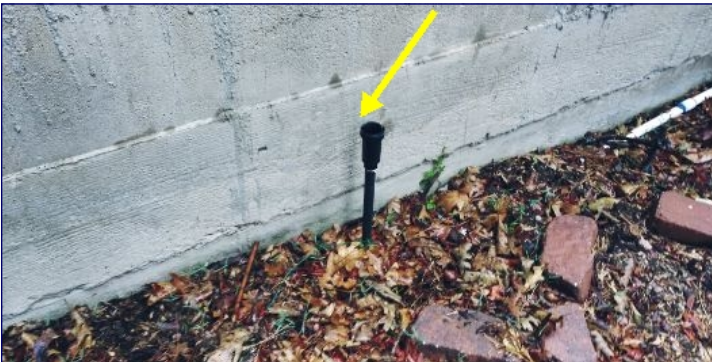
There are missing or broken sprinklers and we recommend service.

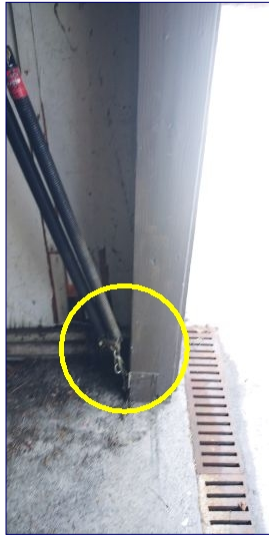
There is no system in place to detect obstructions within the path of the garage door as system is attempting to return to the closed position, which is a safety concern. We recommend one be installed as required in most conditions.

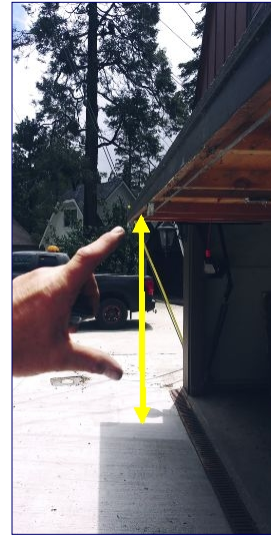
The garage head clearance height is below industry standard, which may impede access for certain vehicles. We recommend further evaluation and service.

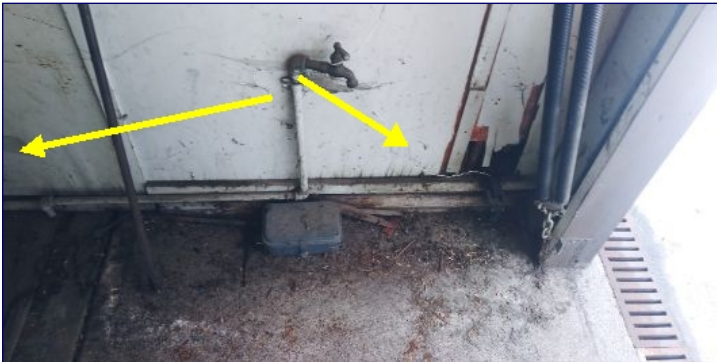
Water damaged, wood rot, and other moisture related damages appear to be present at the base of the wall off the entrance to the garage. We highly recommend further evaluation and service by a licensed termite inspector.

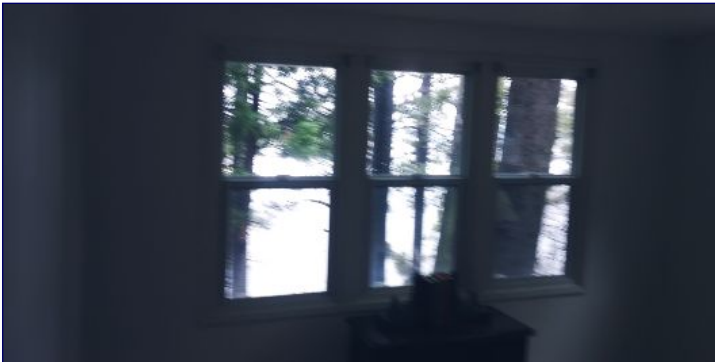
Current standards call for at least two means of emergency egress at every bedroom location. No visible qualifying method of secondary egress was found to be present at all bedroom locations. To qualify the egress systems must comply with minimum emergency egress standards. When two or more doors are not present, which provide egress, at least one window or comparable system must be present which employs a clear opening of a minimum 5.7 square feet, a minimum opening with a width of 20.5", a minimum open vertical opening of 24" , and have a sill height of no more than 44" in vertical height from floor surface. We recommend upgrading the windows located within the bedroom locations to comply with minimum safety standards relevant to the period of time the windows were replaced.

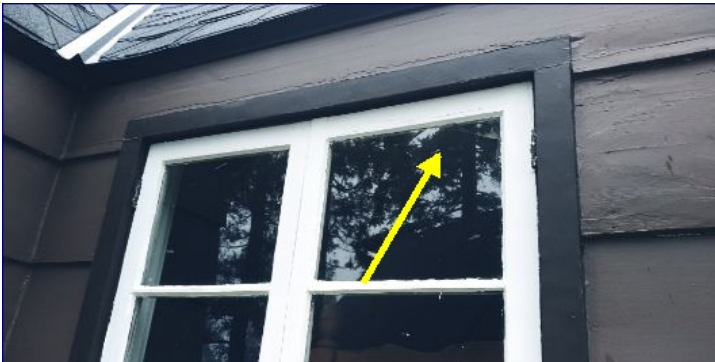
Broken glass at two locations off the detached garage are present, which is a safety hazard and a security issue and we recommend replacement prior to occupancy.

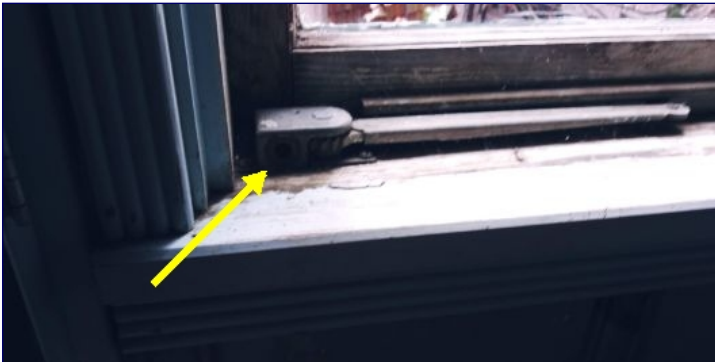
We were unable to access multiple windows to test for functionality due to the lack of hardware at the window crank systems. We recommend further evaluation and service prior to the close of escrow.

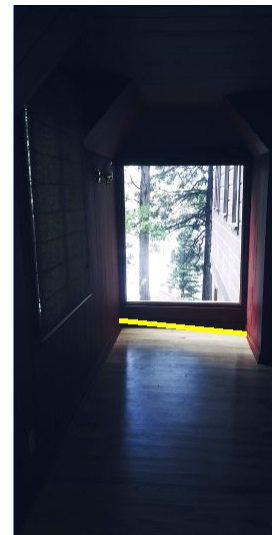
Glass installed at fenestrations which are located within 2' of a door, within a door, adjacent to stairs systems, within a tub/shower system, installed with a interior sill height of 18" or less and a exterior sill height of 30" or greater, etc, are required to be comprised of a tempered glass material or comparable to help prevent injury in the event the glass was broke while accessing or operating in the vicinity of the aforementioned conditions. We recommend the glass be replaced located at bedroom one where the window sill is below 18" from finish floor and at the window located above the tub within bathroom one where the window sits less than the allowed distance from the base of the tub and the window itself, to tempered glass as required.

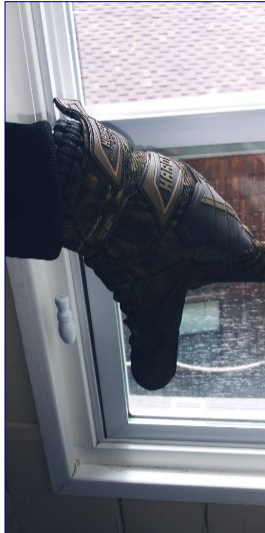
Glass installed at fenestrations which are located within 2' of a door, within a door, adjacent to stairs systems, within a tub/shower system, installed with a interior sill height of 18" or less and a exterior sill height of 30" or greater, etc, are required to be comprised of a tempered glass material or comparable to help prevent injury in the event the glass was broke while accessing or operating in the vicinity of the aforementioned conditions. We recommend the glass be replaced located at bedroom one where the window sill is below 18" from finish floor and at the window located above the tub within bathroom one where the window sits less than the allowed distance from the base of the tub and the window itself, to tempered glass as required.

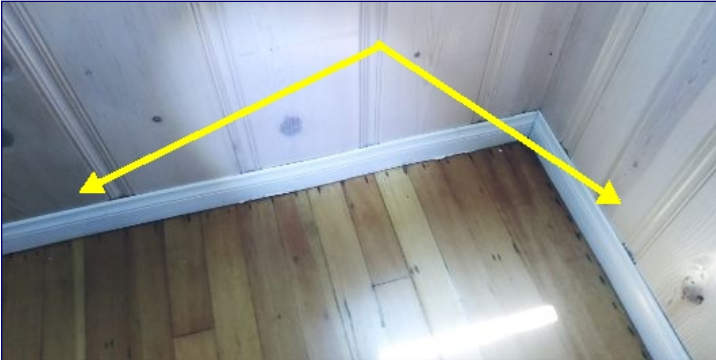
Visible moisture damages are present at the base of the wall and ceilings within the sublevel den. We recommend further evaluation and service by a licensed moisture intrusion specialist.

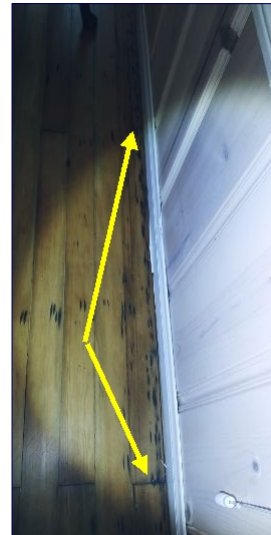
Visible moisture damages are present at the base of the wall and ceilings within the sublevel den. We recommend further evaluation and service by a licensed moisture intrusion specialist.

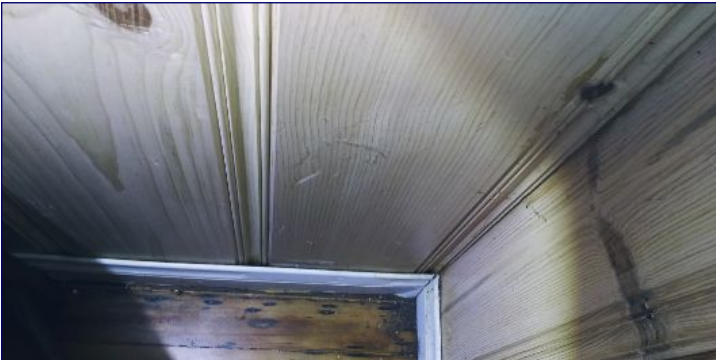
Visible moisture damages are present at the base of the wall and ceilings within the sublevel den. We recommend further evaluation and service by a licensed moisture intrusion specialist.

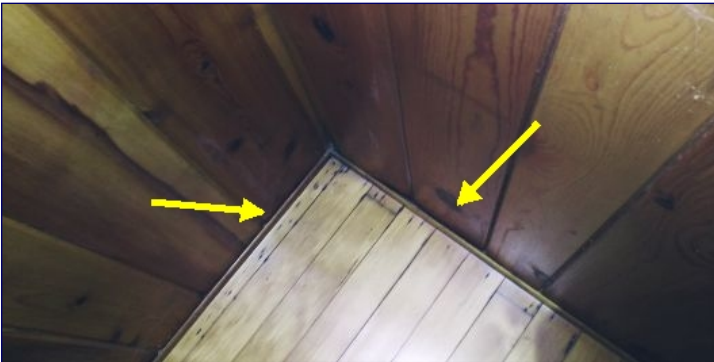
Moisture related damages are present at the base of the wall within the interior of the main structure, off the top floor bedroom areas. We recommend further evaluation and service by a licensed moisture intrusion specialist.

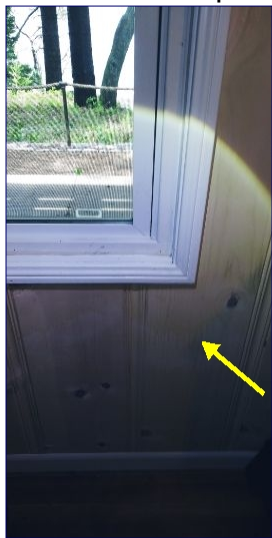
Visible moisture related damages present beneath the window sill within bedroom three. We recommend further evaluation and service.

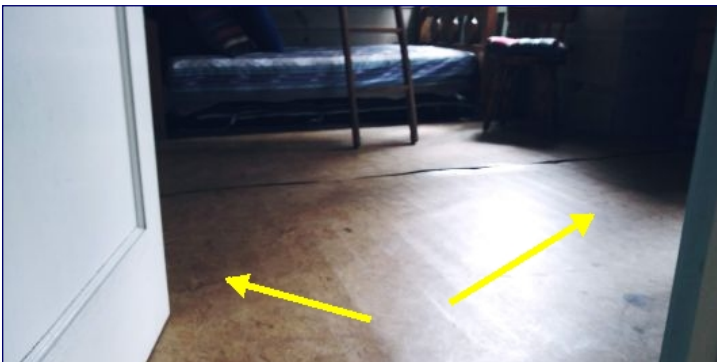
The vinyl flooring possibly contains asbestos materials and is loosely or wavy in its appearance where located within the loft bedroom within the detached structure. We recommend further evaluation and abatement by a licensed asbestos abatement contractor.

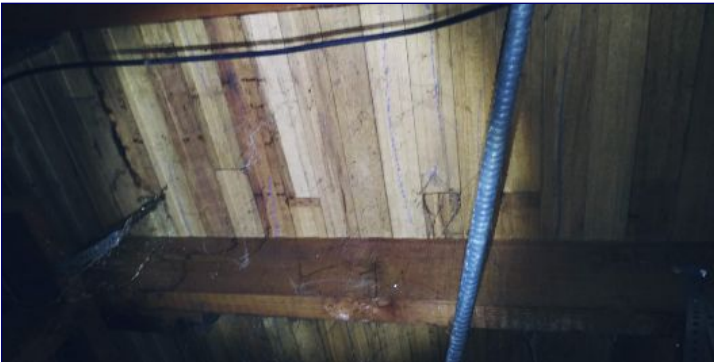
Visible from within the crawlspace, it appears that due to the lack of floor sheathing a majority of the finish wood floor within the interior, has been installed with no support beneath the joints, which may cause undesirable movement, warping, and other abnormal wear. We recommend further evaluation and service.

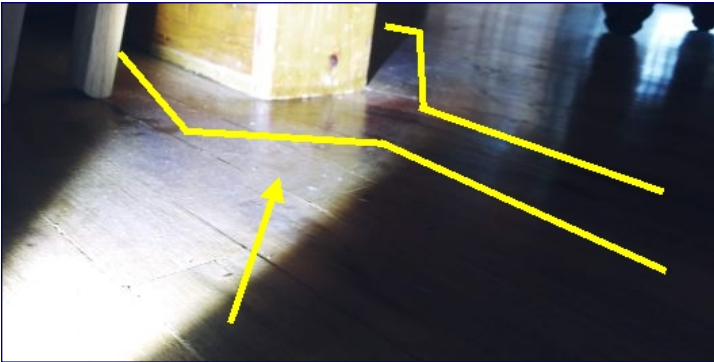
There are abnormal and significantly uneven areas in the flooring, ceilings, and interior door openings were found to be present at one or more locations within the foyer, dining room, and main hall locations. We highly recommend further evaluation and service by a licensed structural engineer prior to the close of escrow.

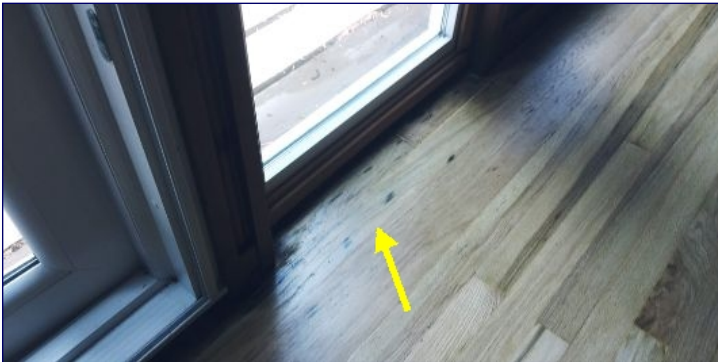
Moisture related damages are present at the base of the wall within the interior of the main structure, off the top floor bedroom areas. We recommend further evaluation and service by a licensed moisture intrusion specialist.

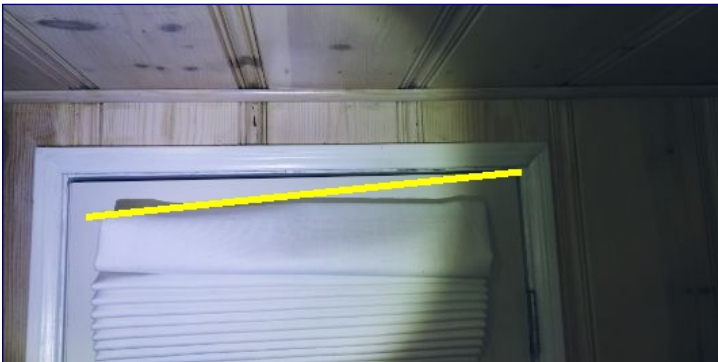
Multiple uneven door reveals present, indicating out of square openings.

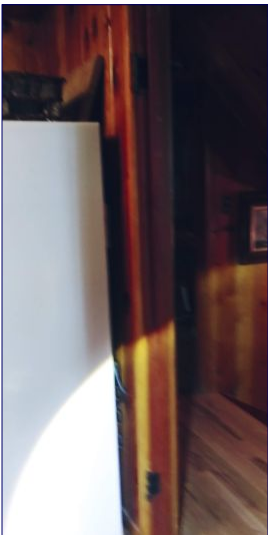
Missing door at one or more locations and we recommend replacement.

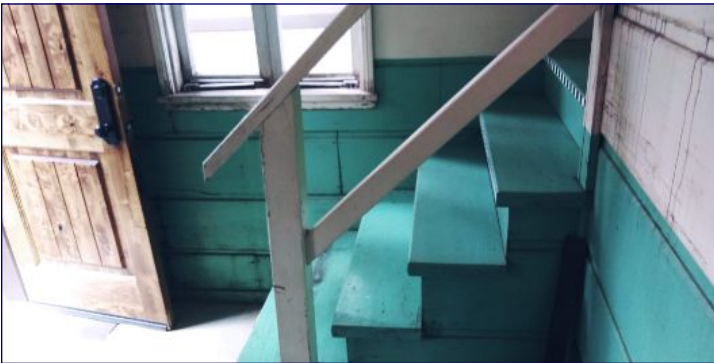
The pickets are spaced over 4" and care should be taken to avoid issues with young children. The aforementioned condition may have been completely acceptable based on the codes in place at the time the was home was built. Although, we feel it is important that you are aware of increased safety standards put in place to help protect you and your family.

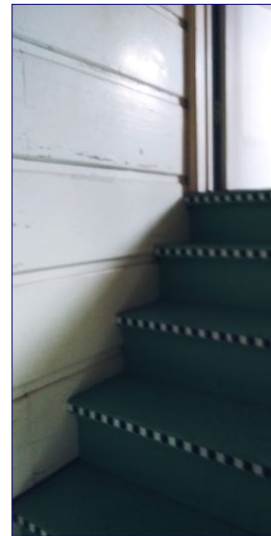
There is no handrail present at one or more locations of the interior stair system, as required by local building and safety standards. We recommend the installation of a mandated and approved railing system.

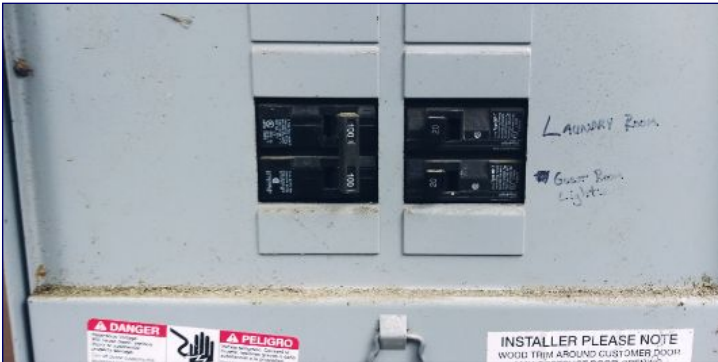
The panel is not clearly labeled and should be in order to properly identify circuits in the event a emergency disconnect is required.

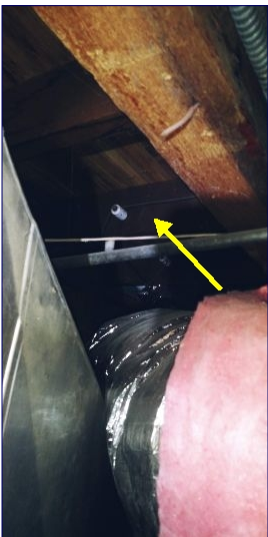
Knob and tube electrical system stipp present and active.

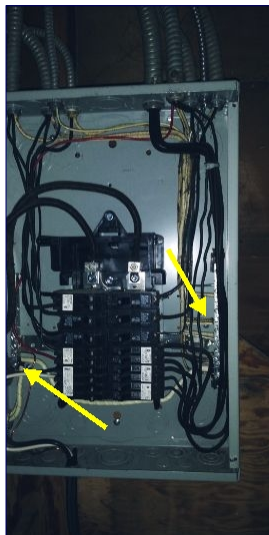
The neutral and bonds are not installed on separate bus bars as required and we recommend further evaluation and service by a licensed electrician

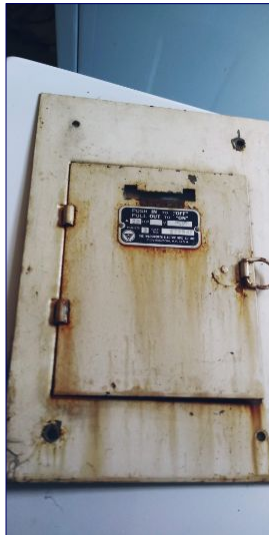
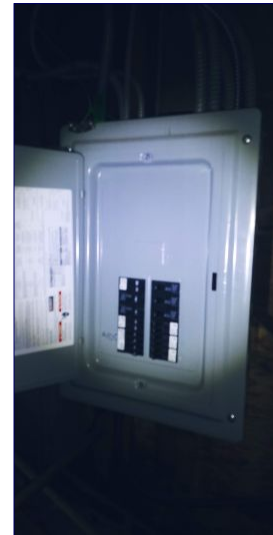
The panel is not labeled clearly and it is recommended to be, in order for the circuits to be properly identified and the loads calculated by an electrician.

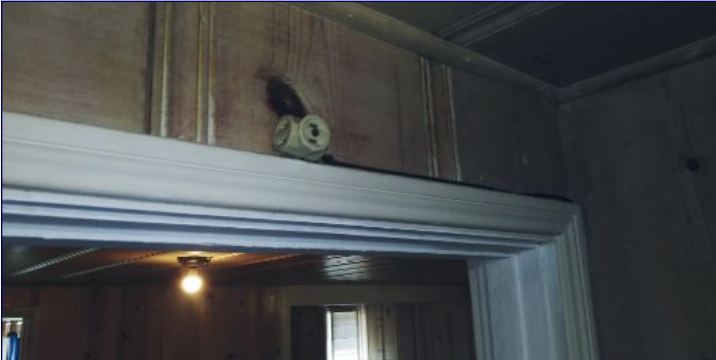
In one or more locations (sublevel main house) we have noted exposed electrical cables ran on the surface of interior walls, which is not permitted. The aforementioned condition is a potential shock hazard and therefore we recommend further evaluation and service by a licensed electrician prior to the close of escrow.

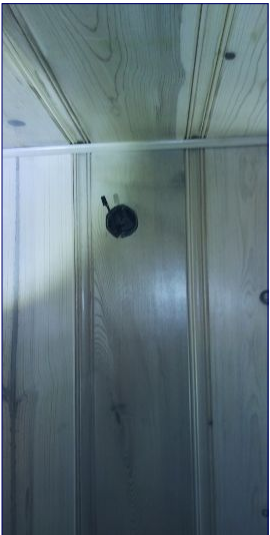
Missing trim, loose, and/or damaged trim at various locations

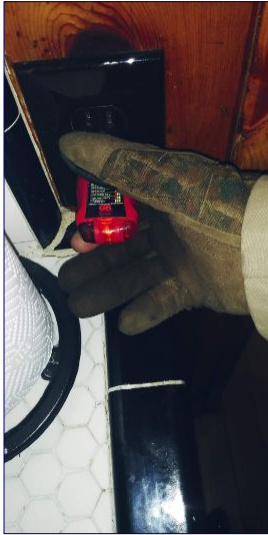
Several interior three prong outlets have not been grounded correctly

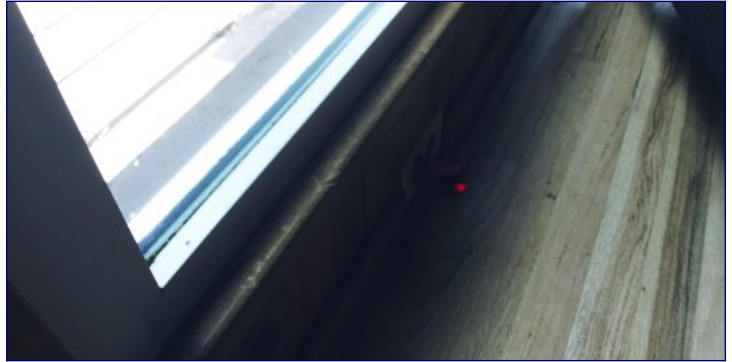
Several interior three prong outlets have not been grounded correctly

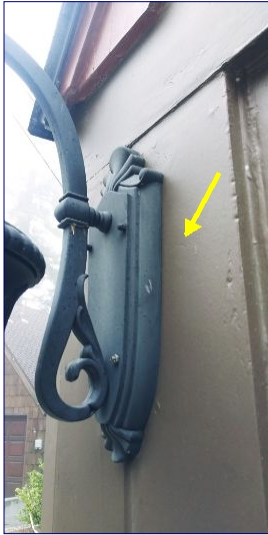
To help prevent moisture intrusion, corrosion of circuits, and related conditions, all exterior electrical fixtures are required to be secured and sealed at the gap between the fixture and the exterior cladding surface. We recommend further evaluation and service.

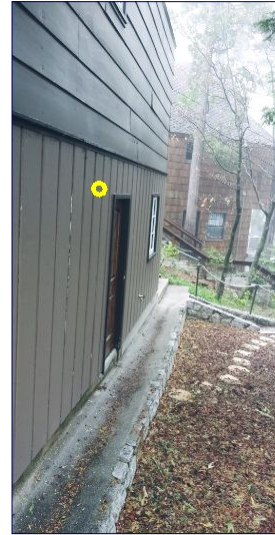
No light present at garage exterior to exterior door, as required by local building codes, to help prevent injury while accessing exits, during limited visibility

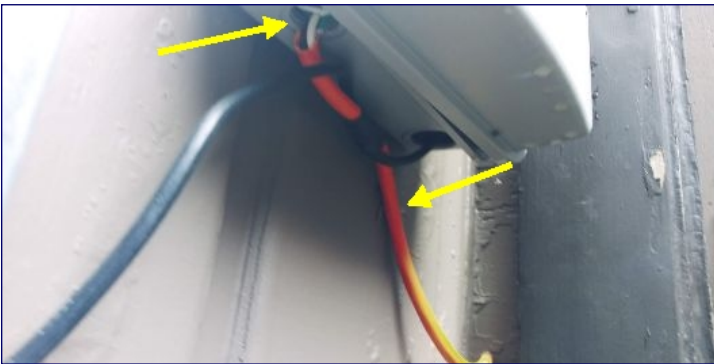
When fixtures are in need of permanent power we recommend that the outlet cover should be changed to one that allows the fixture to be plugged in but at the same time maintaining its moisture resistance.

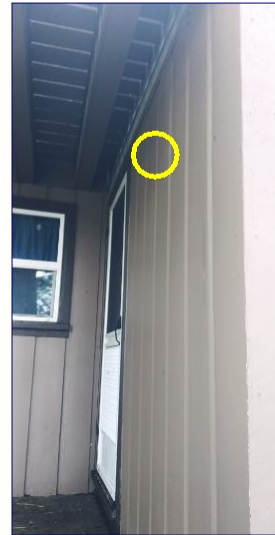
No light present at garage exterior to exterior door, as required by local building codes, to help prevent injury while accessing exits, during limited visibility

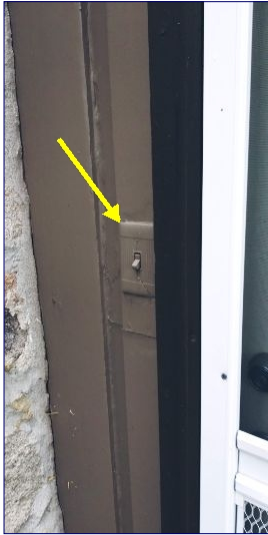
There are various junctions and/or fixtures, which are not recommended for exterior use and should be replaced with approved exterior rated electrical grade materials.

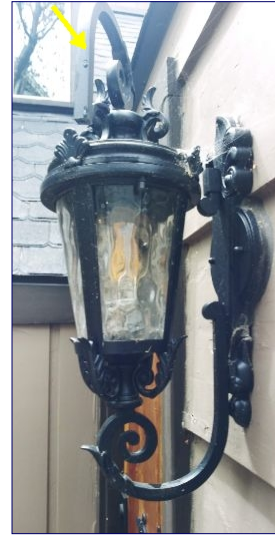
Damaged exterior wall sconce at the rear right elevation. We recommend further evaluation and service.

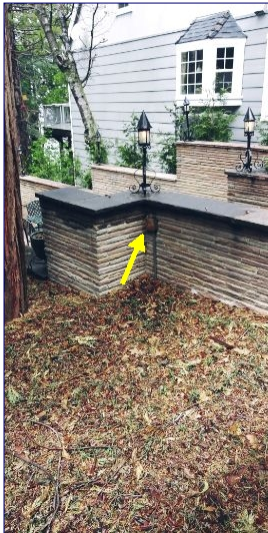
There are various junctions and/or fixtures, which are not recommended for exterior use and should be replaced with approved exterior rated electrical grade materials.

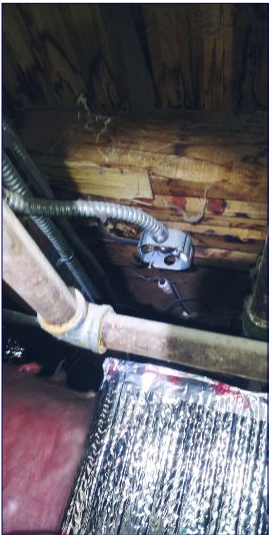
There are multiple unsafely installed electrical connections and/or electrical junctions within the attic. Exposed, spliced, and/or wire natted electrical connections are present outside of a junction box or within a unsealed junction box, either method of installation will not contain electrical arching. This method of installation is easily repaired, but at the same time, is a serious fire and shock hazard. All electrical connections should be made within an approved UL listed junction box, which is properly sealed to contain random arching and we recommend service prior to further occupancy.

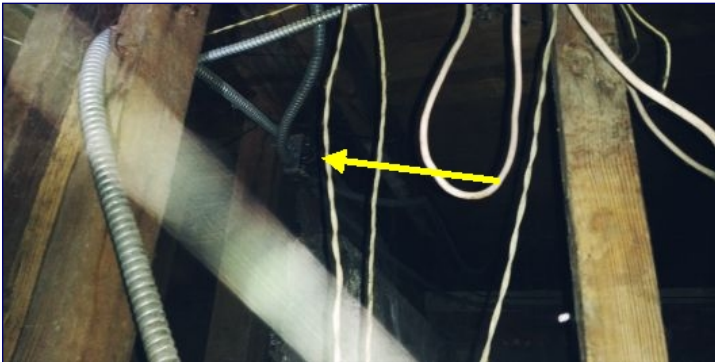
There are multiple unsafely installed electrical connections and/or electrical junctions within the attic. Exposed, spliced, and/or wire nuted electrical connections are present outside of a junction box or within a unsealed junction box, either method of installation will not contain electrical arcing. This method of installation is easily repaired, but at the same time, is a serious fire and shock hazard. All electrical connections should be made within an approved UL listed junction box, which is properly sealed to contain random arcing and we recommend service prior to further occupancy.

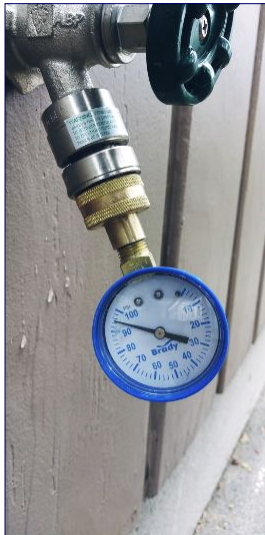
The water pressure should never exceed 70 PSI at the interior water pressure, as it will prematurely deteriorate the seals at all interior plumbing fixtures, deteriorate the water heater, and can be the source of numerous water leaks.

- No water pressure regulator was noted at the time of inspection.
- Due to the measured water pressure at the water supply system we recommend the installation of a pressure regulator at the entrance into the structure, past the irrigation connection. The regulator will reduce water pressure and therefore reduce the likelihood of expensive water leaks caused by fixture failures.
- Recommend adjustment of the regulator or replacement, to reduce pressure of water at the water supply system.

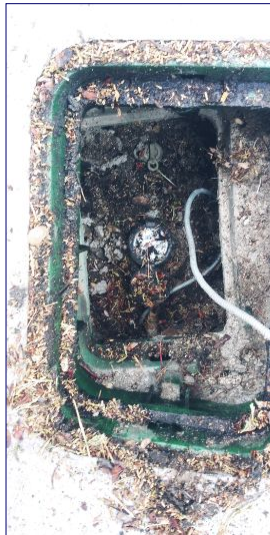
Since this home was constructed prior to 1950 you may wish to have the main water supply line tested for lead.

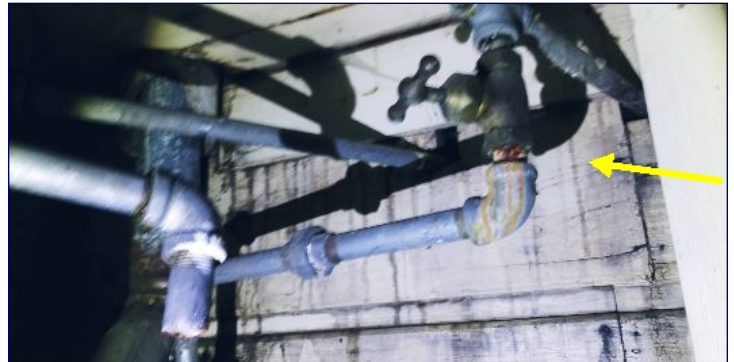
There are blisters on the body of the galvanized water pipes that should be evaluated

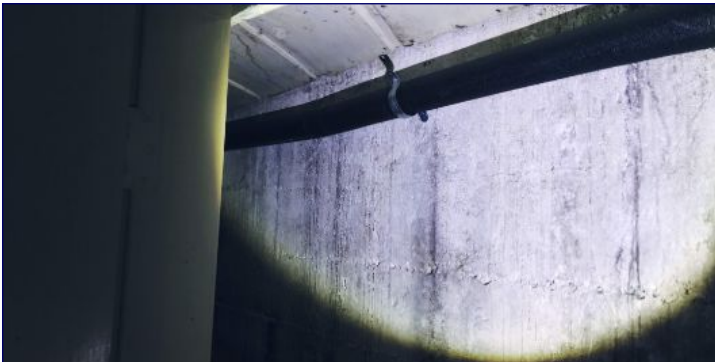
Pex lines are ran on the walls surface and will be exposed to damages. Pex material should be ran within a protective chase to prevent accidental impact damages.

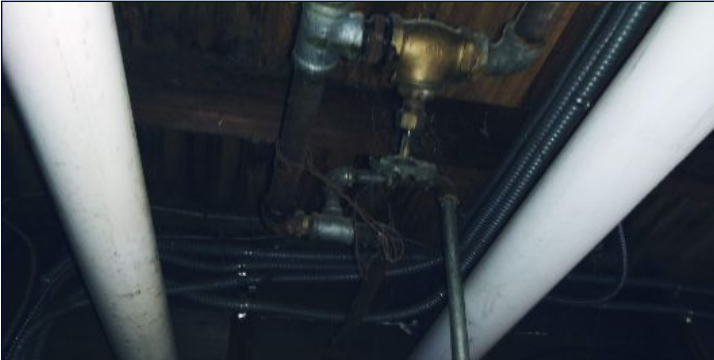
There are blisters on the body of the galvanized water pipes that should be evaluated

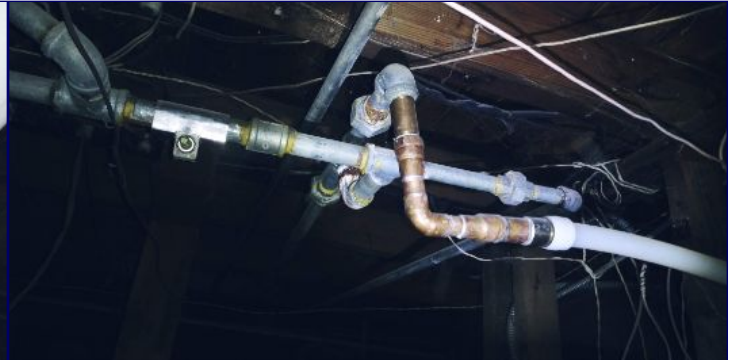
There are surface-mounted water pipes that are not insulated and are therefore not energy efficient and if location warrants, will be susceptible to freezing, and you may wish to verify the installation permit.

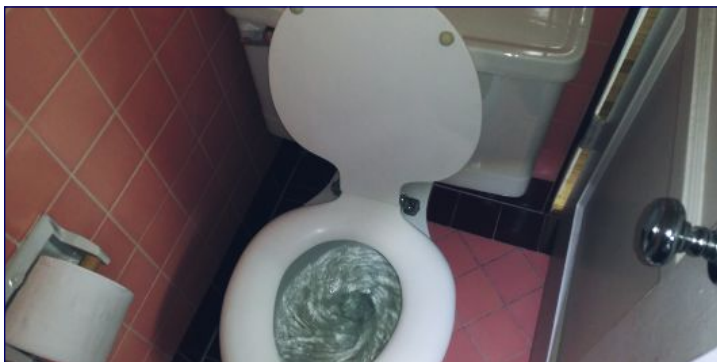
One or more toilets runs continously and we recommend further evaluation and service.

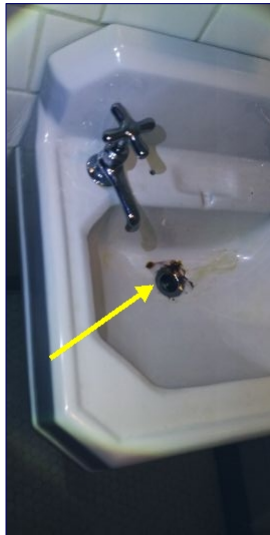
Damaged sink present within bathroom two. We recommend further evaluation and service with the intention of replacement.

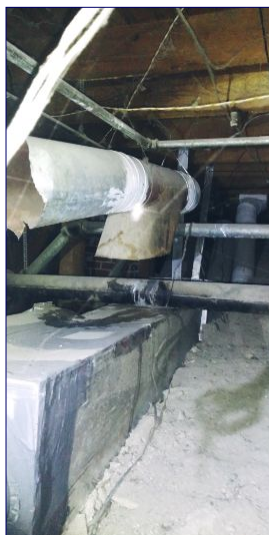
Sections of the remaining cast iron sewer risers and/or laterals are deteriorated and evidence of leaking is present. In addition, one or more interior drains are slow and/or not functioning properly. We recommend further evaluation by a licensed plumbing contractor with the intention of complete replacement

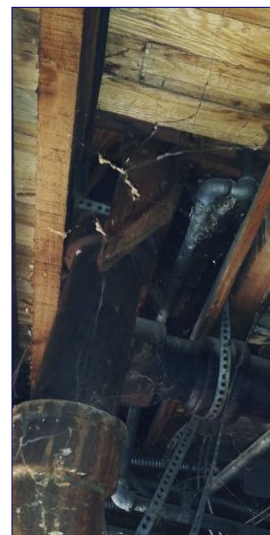
Sections of the remaining cast iron sewer risers and/or laterals are deteriorated and evidence of leaking is present. In addition, one or more interior drains are slow and/or not functioning properly. We recommend further evaluation by a licensed plumbing contractor with the intention of complete replacement

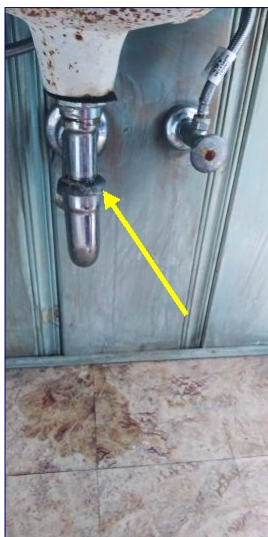
Leak at sink drain within the interior of the detached structures bathroom sink. We recommend further evaluation and service .

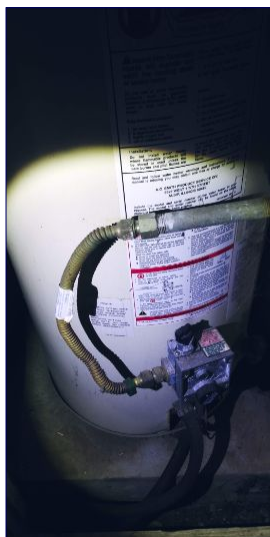
Gas supply flex connectors are installed which are old, outdated, comprised of materials no longer permitted, and considered to be unsafe. We recommend replacement of relevant connectors.

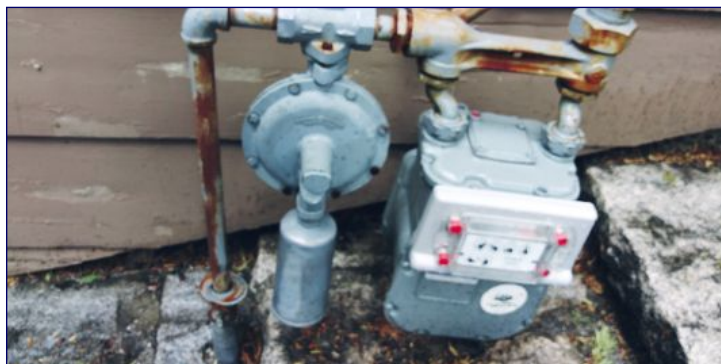
You may wish to keep a wrench at the meter, in case of a emergency

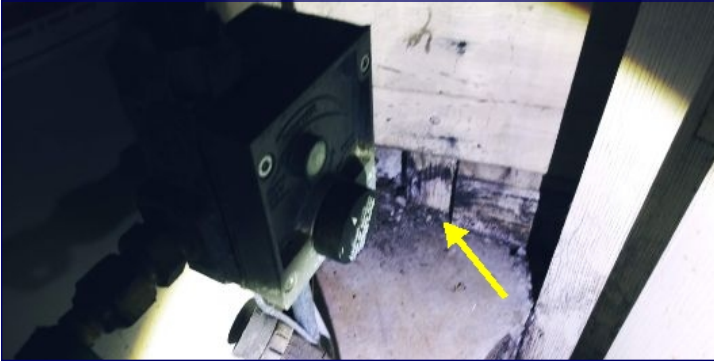
Deteriorated materials present at the water heater enclosure and/or access door and we recommend service.

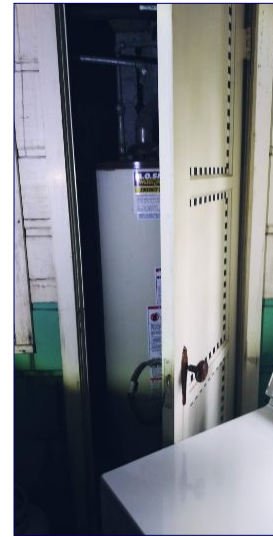
At the water heater located within the guest house, we have noted the combustion air available to the water heaters is inadequate, due to the undersized ventilation grates and the under sized bathroom those greats are attempting to draw combustion air from. We recommend the water heaters not be employed until properly serviced by a licensed plumbing contractor.

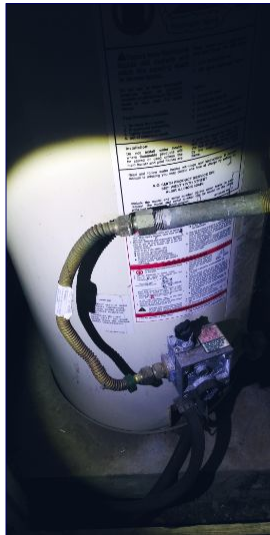
Sediment trap missing at the gas supply line and we recommend service.

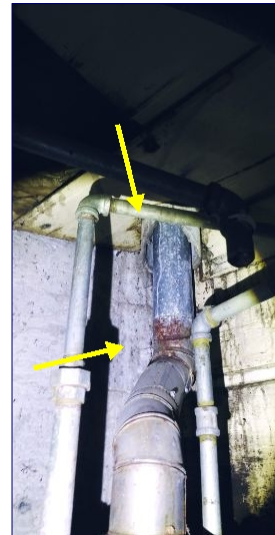
Moisture related damages are present at the vent pipe for the water heating unit which services the detached structure. We recommend further evaluation and service prior to any further attempts to use.

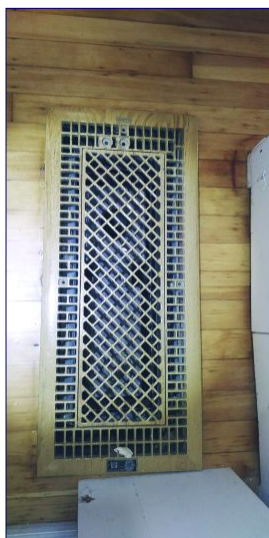
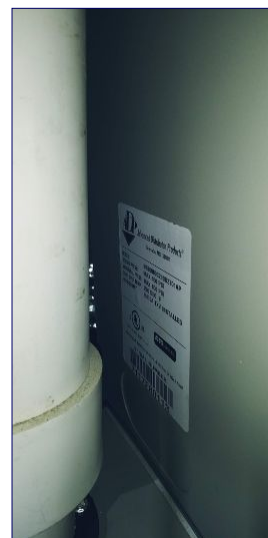
Floor heaters are no longer employed in new construction due to their inherent safety issues. We have noted some possible heat damages and/or carbonization at perimeter of the system. We recommend the system be further evaluated by a licensed HVAC contractor with the intent of replacement.

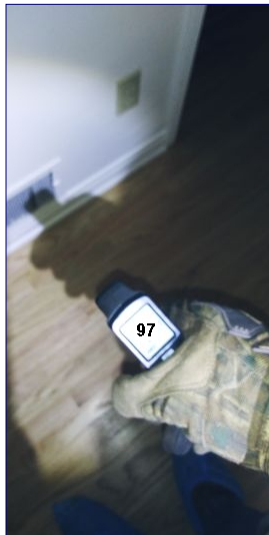
Heat supply temperature.

- In our opinion the supplied temperature and/or air flow is substandard at one or more locations. We recommend further evaluation and service by a licensed HVAC contractor.
- Within the interior ceiling of the sublevel portion of the unit, we have noted rusted registers at one or more locations, indicating a past or active interior elevated moisture levels condition within the home. We recommend further evaluation and service by a licensed HVAC contractor prior to the close of escrow.
- One or more supply and/or return registers are deteriorated due to moisture exposure. Rust is present within the metal ducting system due to the system be ran through the corrosive concrete foundation . We recommend further evaluation by a licensed HVAC contractor with the intention of the replacement of the system.

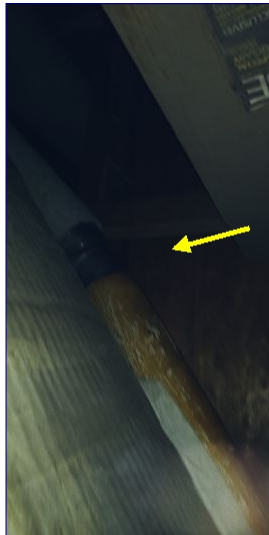
The B vent has been ran through the interior of an abandoned friable asbestos based transite pipe, which can be accessed from the interior of the home at closet and crawlspace areas. Due to the potential safety hazards when dealing with ACM containing materials, we recommend further evaluation and service by a licensed asbestos abatement contractor prior to further occupancy.

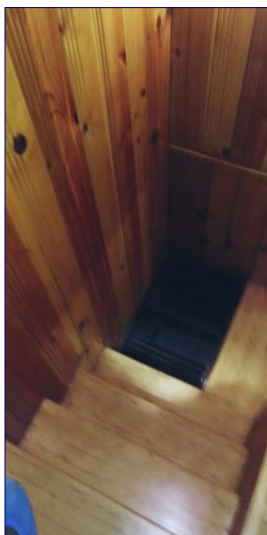
The return air compartment is located in the surface of the main interior stair case landing, Upon operation and draw of intake air, the floor mounted location will promote the introduction of contaminants into the HVAC system, increasing the likelihood of functionality issues. We recommend further evaluation and service by a licensed HVAC contractor.

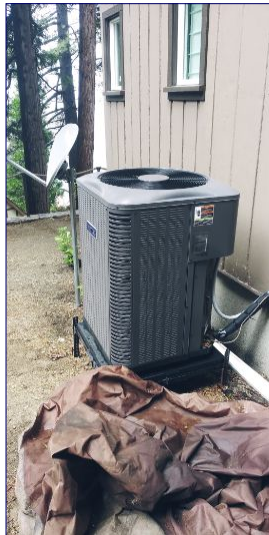
The AC compressor is installed on a unstable base, and is also out of its level as required by the manufacturers installation instructions. We recommend further evaluation and service by a licensed HVAC contractor prior to any continued use.

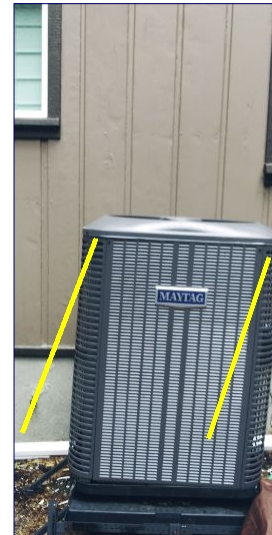
The AC compressor is installed on a unstable base, and is also out of its level as required by the manufacturers installation instructions. We recommend further evaluation and service by a licensed HVAC contractor prior to any continued use.

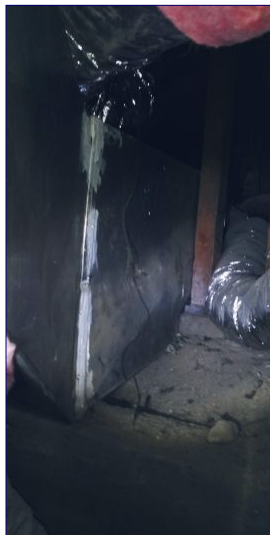
Several sections of ducting are laying directly on grade and/or attic floor and are recommended to be elevated to prevent deterioration and maximize efficiency.

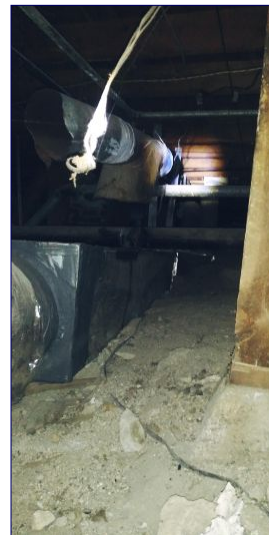
Several sections of ducting are laying directly on grade and/or attic floor and are recommended to be elevated to prevent deterioration and maximize efficiency.

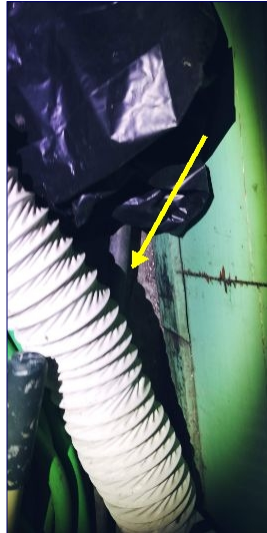
The dryer exhaust duct installed at the dryer connection is comprised of flex materials and is ran to a length excessive to the manufacturers installation instructions. Due to the inherent fire hazard present in dryer exhaust systems which are unsafely installed, we recommend further evaluation and service by a licensed HVAC contractor.

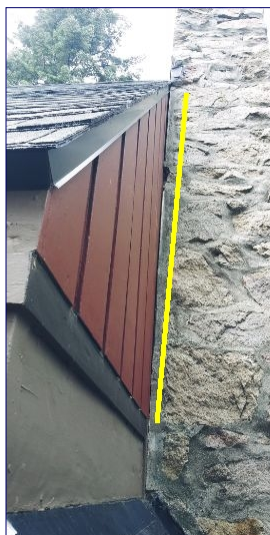
Based on measurements taken at the interior mantel, the living room fireplace appears to have shifted, and now sits out of square. In addition, it appears that a large portion of the upper masonry stack has been rebuilt, based on materials differences and grout color inconsistencies. Based on the two aforementioned observations, it is our recommendation the fireplace be further evaluated by a Licensed NFPA inspector prior to any attempts to utilize.

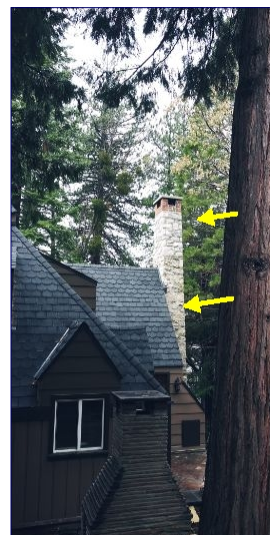
Based on measurements taken at the interior mantel, the living room fireplace appears to have shifted, and now sits out of square. In addition, it appears that a large portion of the upper masonry stack has been rebuilt, based on materials differences and grout color inconsistencies. Based on the two aforementioned observations, it is our recommendation the fireplace be further evaluated by a Licensed NFPA inspector prior to any attempts to utilize.

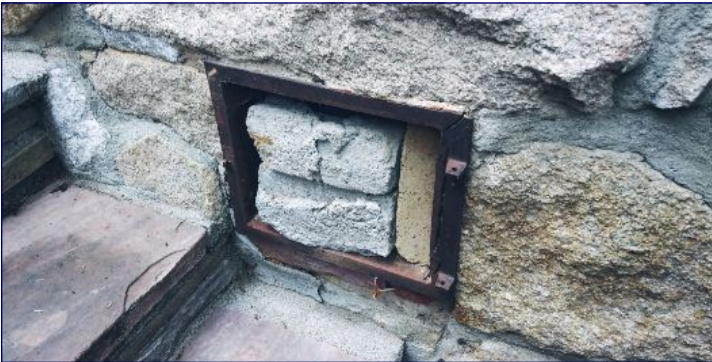
Missing ash box door and we recommend service prior to any attempt to employ system.

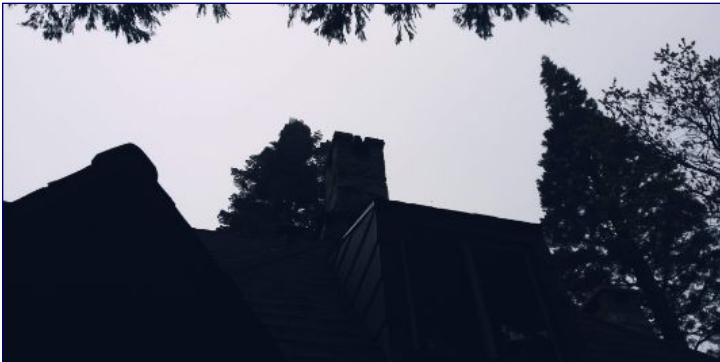
Cracked and deteriorated crown, which should be serviced to prevent additional damages.

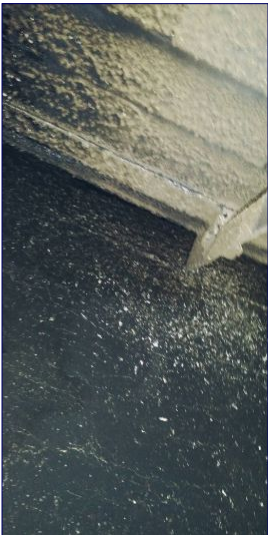
An approved spark arrester is defined as a device constructed of non combustible materials, 12 gauge minimum welded or woven wire mesh, with maximum  $\frac{1}{2}$  inch openings, or cast-iron plate,  $\frac{3}{16}$  inch minimum thickness,

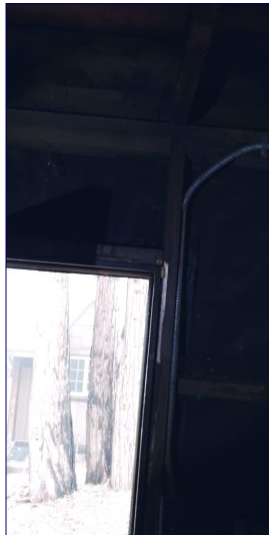
Foundation access door not framed correctly to properly transfer structural load over and around the opening as required and often opiortrayed with a typical header to king stud connection. We recommend further evaluation and service by a licensed structural engineer.

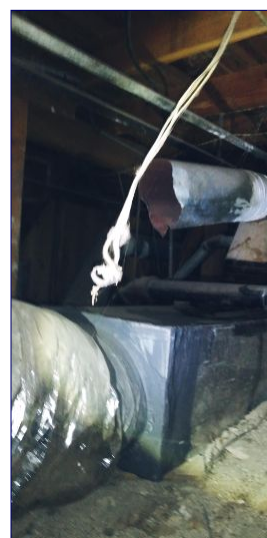
There is trash located within the crawlspace, which will promote fungus growth and the introduction to pests.
