# *Safe Guard Property Inspections, LLC*

## Residential Inspection Report

232 John Muir Rd., Lake Arrowhead , CA 92352  
Inspection prepared for:  
Real Estate Agent: Monique Richter - Dilbeck Real Estate

Date of Inspection: 4/30/2019 Time: 11:00  
Age of Home: 1930 Size: 2625  
Weather: Sunny  
Agent buyers present, Buyers present, Inspector present

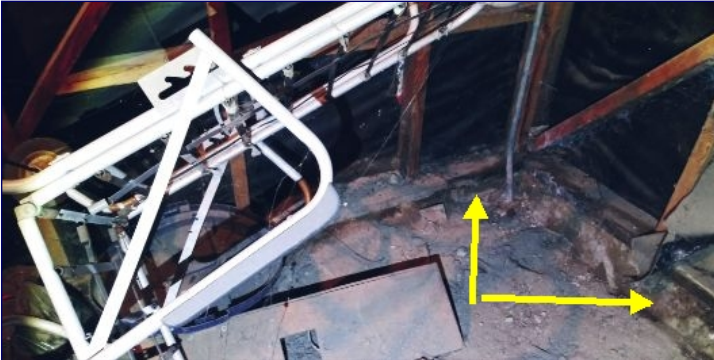
Sections of the concrete foundation walls we observed as being deteriorated, missing, removed, and/or severely out of plumb at one or more locations within the crawlspace of the main structure, as well as within the detached unit. The foundation wall has been skimmed coated in areas, which is falling off the structure and in need of repair. The rear foundation wall was observed and measured as being over an 1.5" out of plumb, leaning towards the tow of the slope. Furthermore we observed sections of concrete foundation walls missing, damaged, and/or spalling and therefore we highly recommend a complete evaluation by a licensed structural engineer and/or a licensed concrete repair specialist prior to the close of escrow.

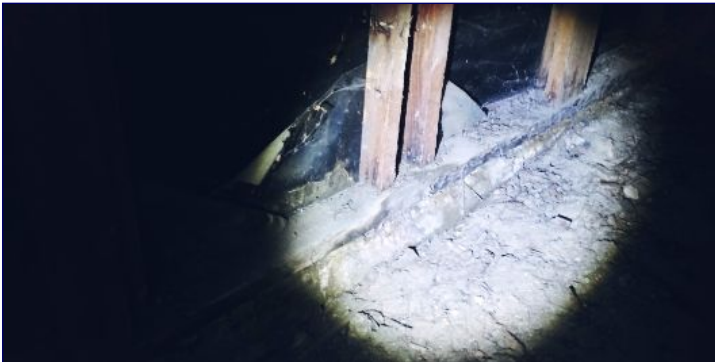
Earth to wood contact will cause rapid deterioration to wood based sill plates, which has already occurred. Therefore, we recommend a functional separation be made between wood based structural components and the corrosive soils . We recommend further evaluation and service.

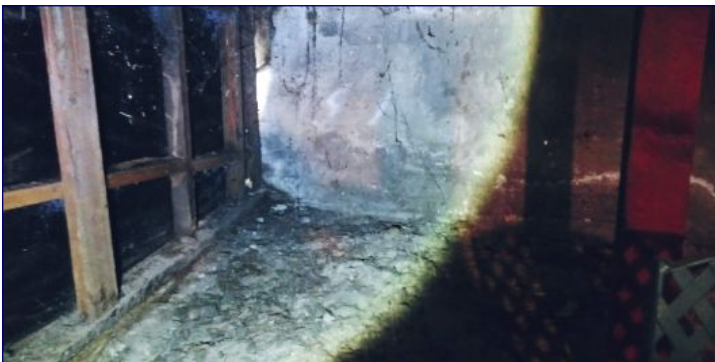
Earth to wood contact will cause rapid deterioration to wood based sill plates, which has already occurred. Therefore, we recommend a functional separation be made between wood based structural components and the corrosive soils . We recommend further evaluation and service.

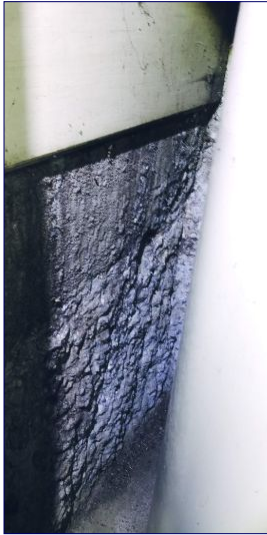
Severe spalling has been noted at the interior foundation wall located beneath the detached structure, visible from within the laundry room cabinetry. Spalling allows the weakening of concrete systems by allowing excess moisture to result in the flaking of concrete surfaces. The aforementioned condition combined with the visible mold growth and elevated moisture levels within the same vicinity, indicate a chronic moisture issue. We recommend further evaluation and service prior to the close of escrow.

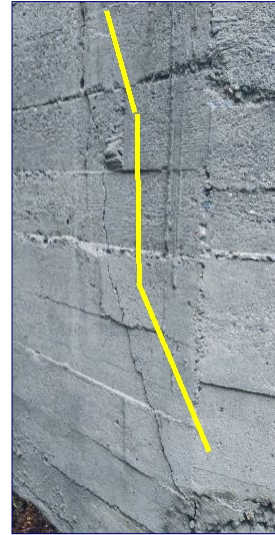
There are multiple atypical cracks, (LARGE AND/OR DISPAED) at the foundation walls, which appear related to unstable soils and excess exposure to moisture. Regardless, the system should be evaluated by a specialist and repaired as directed.

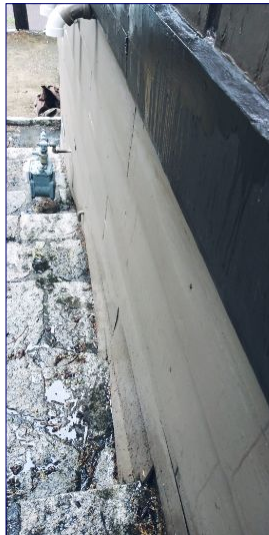
Sections of the concrete foundation walls we observed as being deteriorated, missing, removed, and/or severely out of plumb at one or more locations within the crawlspace of the main structure, as well as within the detached unit. The foundation wall has been skimmed coated in areas, which is falling off the structure and in need of repair. The rear foundation wall was observed and measured as being over an 1.5" out of plumb, leaning towards the tow of the slope. Furthermore we observed sections of concrete foundation walls missing, damaged, and/or spalling and therefore we highly recommend a complete evaluation by a licensed structural engineer and/or a licensed concrete repair specialist prior to the close of escrow.

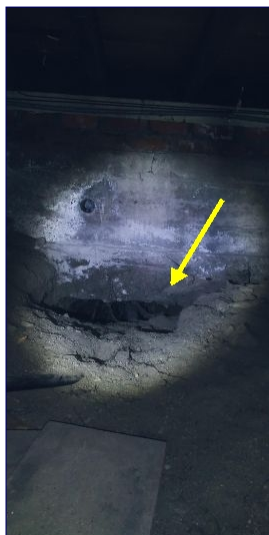
A sizable hole has been cut into the foundation wall for reasons unknown. The hole has been left without bracing or a header to compensate for the missing section of load bearing foundation support system. We recommend further evaluation and service prior to the close of escrow.

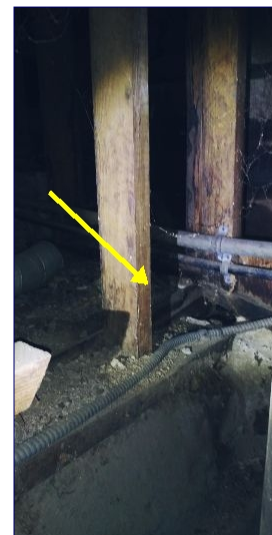
Earth to wood contact will cause rapid deterioration to wood based sill plates, which has already occurred. Therefore, we recommend a functional separation be made between wood based structural components and the corrosive soils . We recommend further evaluation and service.

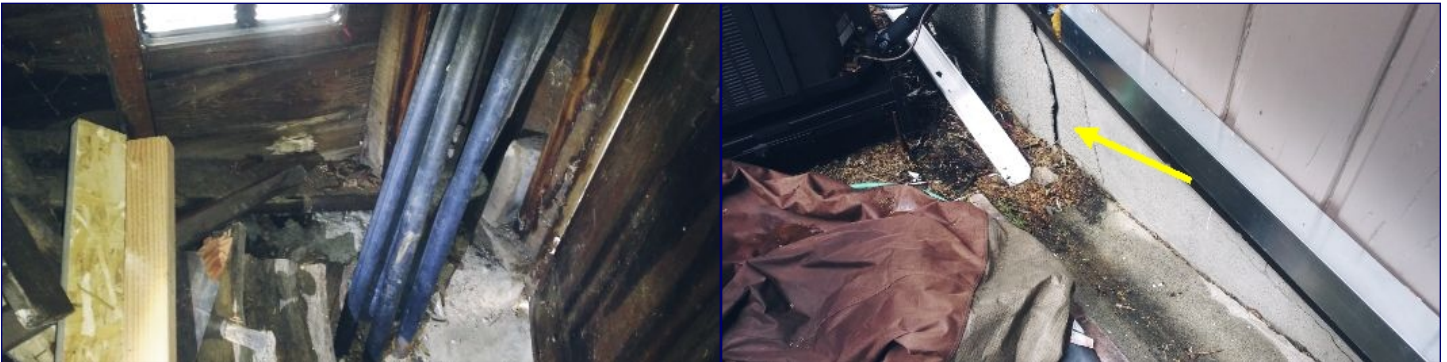
Earth to wood contact will cause rapid deterioration to wood based sill plates, which has already occurred. Therefore, we recommend a functional separation be made between wood based structural components and the corrosive soils . We recommend further evaluation and service.

Sections of the concrete foundation walls we observed as being deteriorated, missing, removed, and/or severely out of plumb at one or more locations within the crawlspace of the main structure, as well as within the detached unit. The foundation wall has been skimmed coated in areas, which is falling off the structure and in need of repair. The rear foundation wall was observed and measured as being over an 1.5" out of plumb, leaning towards the tow of the slope. Furthermore we observed sections of concrete foundation walls missing, damaged, and/or spalling and therefore we highly recommend a complete evaluation by a licensed structural engineer and/or a licensed concrete repair specialist prior to the close of escrow.

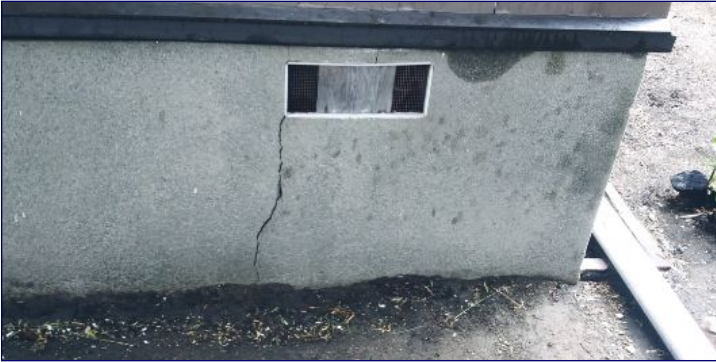
There are multiple atypical cracks, (LARGE AND/OR DISPALED) at the foundation walls, which appear related to unstable soils and excess exposure to moisture. Regardless, the system should be evaluated by a specialist and repaired as directed.

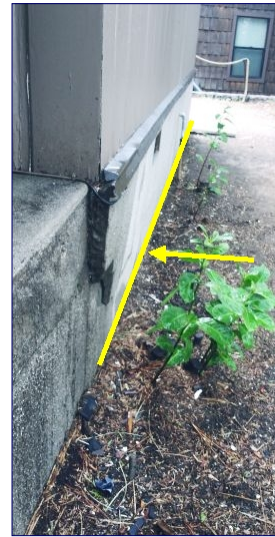
Sections of the concrete foundation walls we observed as being deteriorated, missing, removed, and/or severely out of plumb at one or more locations within the crawlspace of the main structure, as well as within the detached unit. The foundation wall has been skimmed coated in areas, which is falling off the structure and in need of repair. The rear foundation wall was observed and measured as being over an 1.5" out of plumb, leaning towards the tow of the slope. Furthermore we observed sections of concrete foundation walls missing, damaged, and/or spalling and therefore we highly recommend a complete evaluation by a licensed structural engineer and/or a licensed concrete repair specialist prior to the close of escrow.

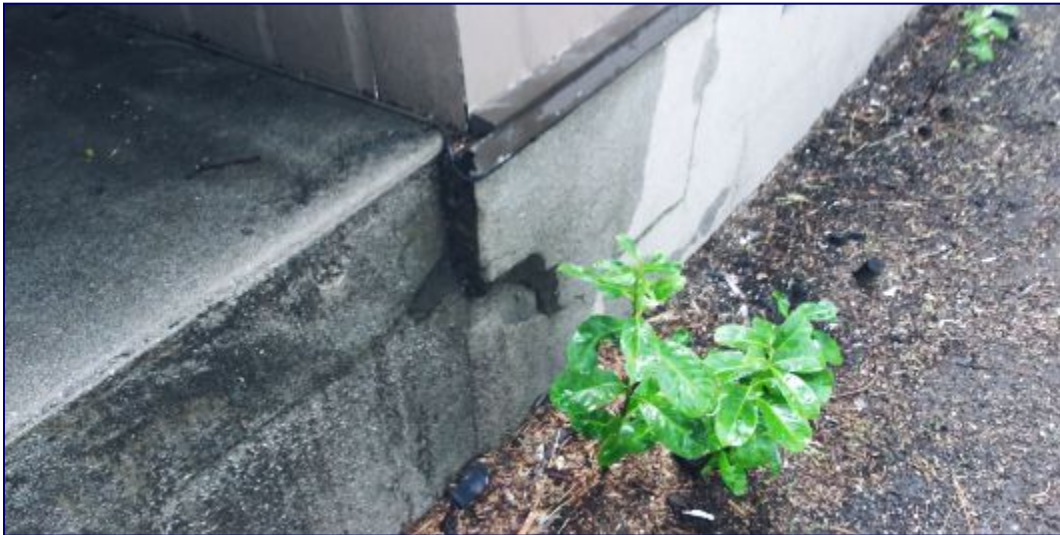
Sections of the concrete foundation walls we observed as being deteriorated, missing, removed, and/or severely out of plumb at one or more locations within the crawlspace of the main structure, as well as within the detached unit. The foundation wall has been skimmed coated in areas, which is falling off the structure and in need of repair. The rear foundation wall was observed and measured as being over an 1.5" out of plumb, leaning towards the tow of the slope. Furthermore we observed sections of concrete foundation walls missing, damaged, and/or spalling and therefore we highly recommend a complete evaluation by a licensed structural engineer and/or a licensed concrete repair specialist prior to the close of escrow.

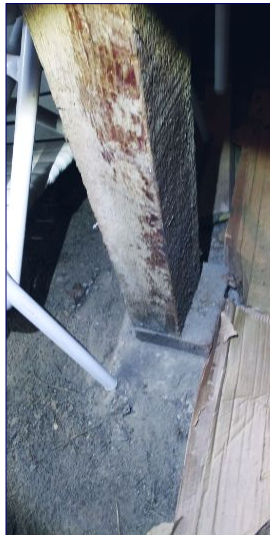
No structural/seismic hardware connections at post to beam connections

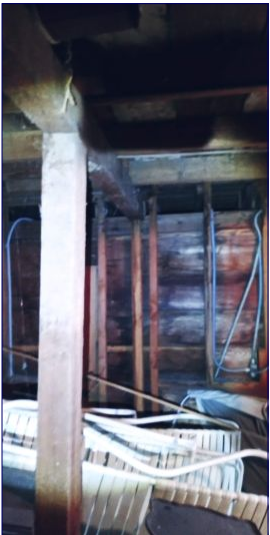
Leaning and off center structural support posts are present and should be serviced as soon as possible. Leaning posts indicate considerable movement due to structural failure and we recommend further evaluation and repair prior to occupancy. Furthermore beam transitions are not properly supported by a support post and we recommend service.

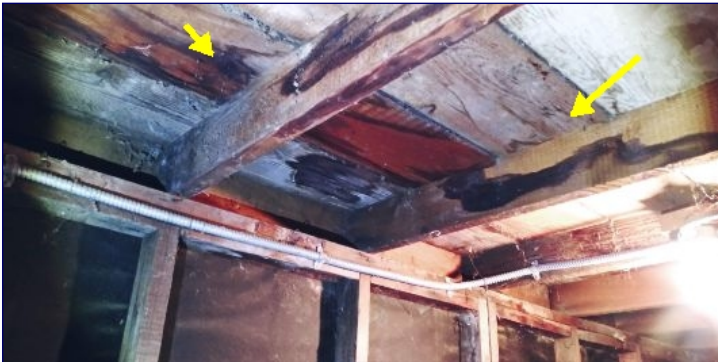
Significant moisture related damages present at the sub floor, visible from beneath the home. A portion of the moisture related damages appear to be caused by water runoff flowing from the front elevation stemwall and into the foundation crawlspace, due to the lack of a functional drainage system. To help prevent further accelerated deterioration of wood based structural components and concrete foundation walls, we highly recommend further evaluation and service prior to the close of escrow.

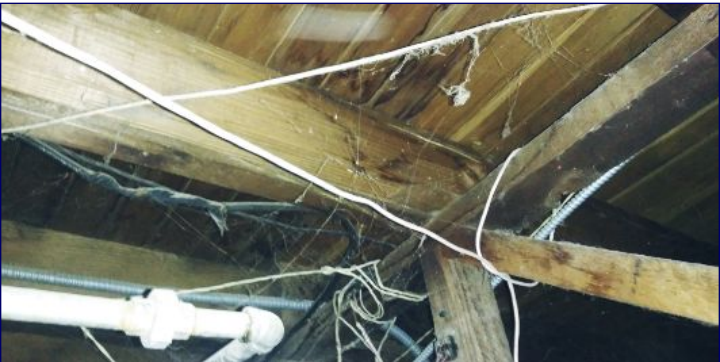
Extensive moisture and termite related damages are present at the subflooring beneath the bathroom and kitchen areas, which appear to be caused by a history of sewer leaks, failed shower systems, and water supply system leaks. We recommend further evaluation and service by a licensed termite, mold remediation contractor, and carpenter.

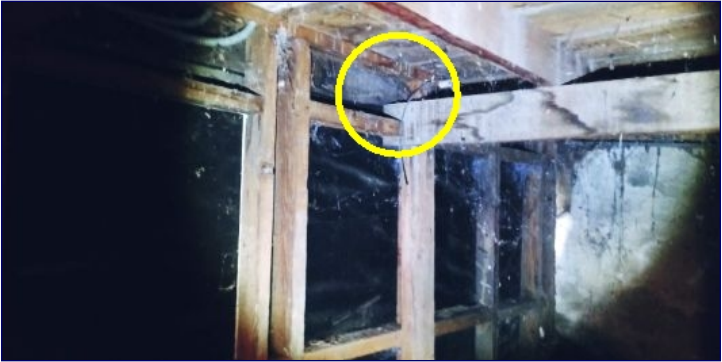
Load transfer missing at joist to cripple wall connection within the main foundation crawlspace at one or more locations. We recommend further evaluation and service by a licensed structural engineer.

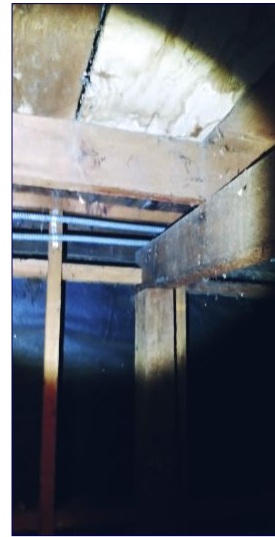
Load transfer missing at joist to cripple wall connection within the main foundation crawlspace at one or more locations. We recommend further evaluation and service by a licensed structural engineer.
